# ASSESS DETECT REPORT

# **Assess Summary Report**

Claim No. Assess\_Demo\_012

**Property Address** 123 MAIN ST

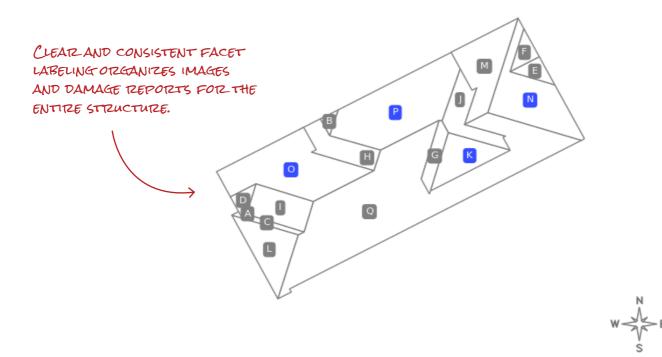
**Roof Model**

Summary of findings: Directional hail, most damage on facet P and O. Replace roof. No damage to walls, window screens, personal property, fence.

Decision	Facet
Replace	P, N, O
Repair

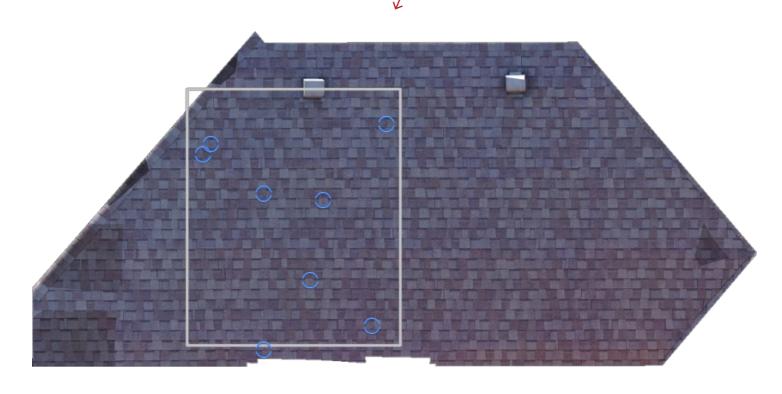
#### **Facet**

aged vents, possibly damaged, replace

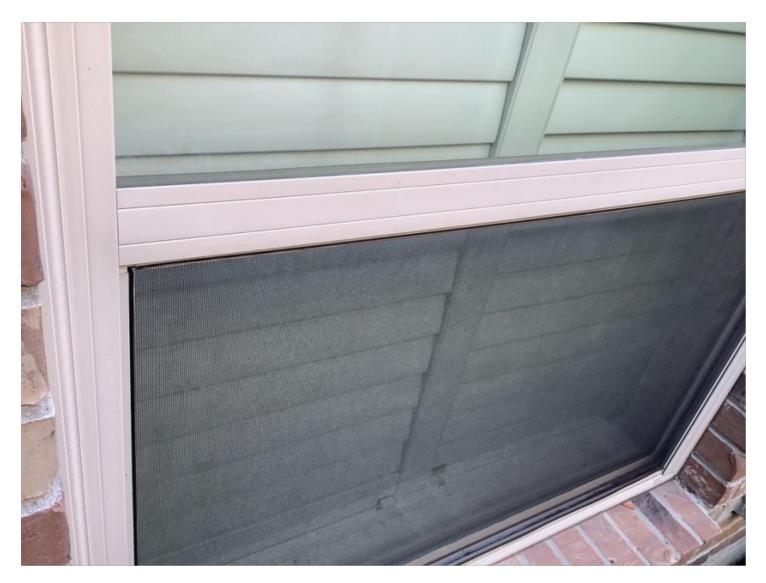
# **Image 1**

no damage to screens

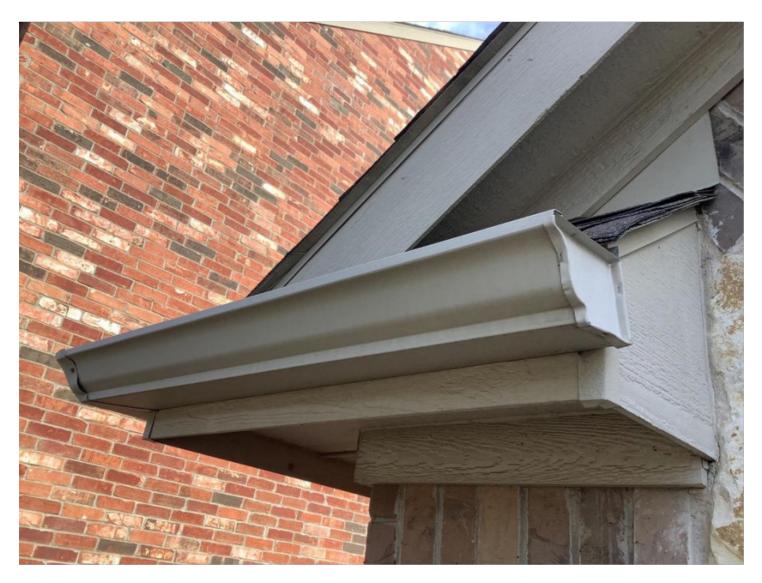
Image 1

not damaged

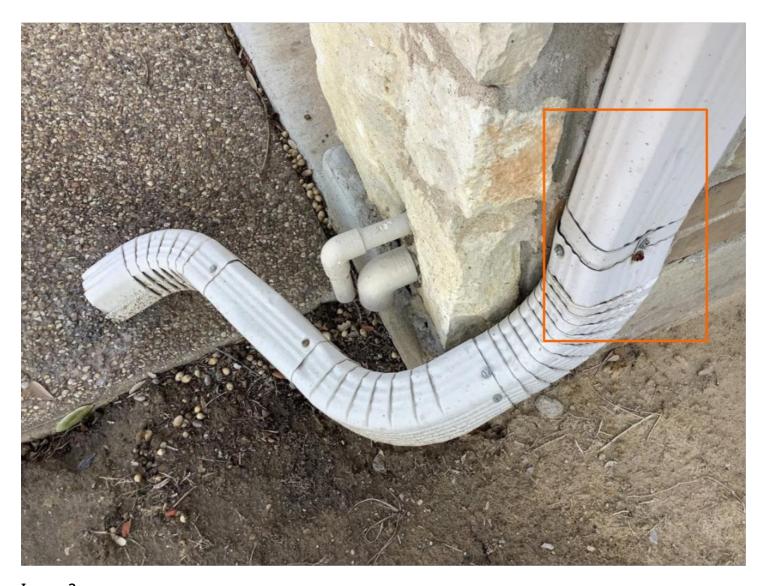
Image 2

Example note: Downspout not damaged

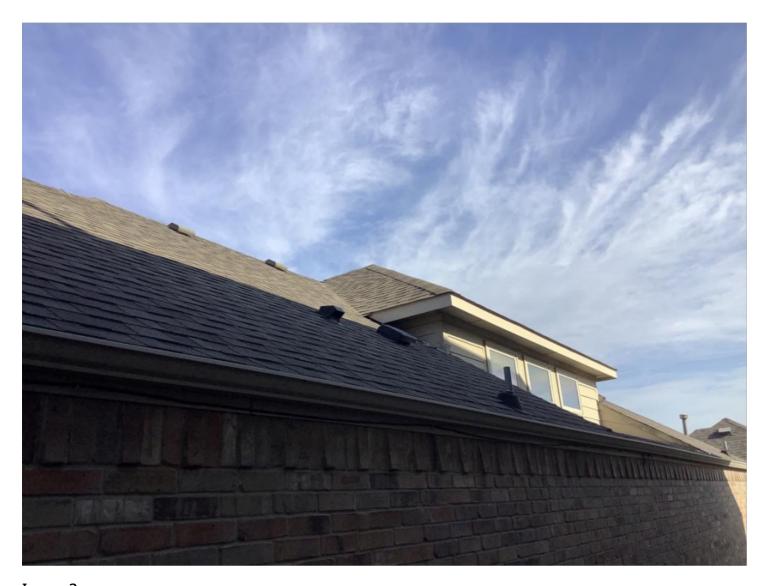
Image 3

no visible damage to gutter
