TREE

A CLEAR PATH TO ANSWERS

**EAGLEVIEW**®

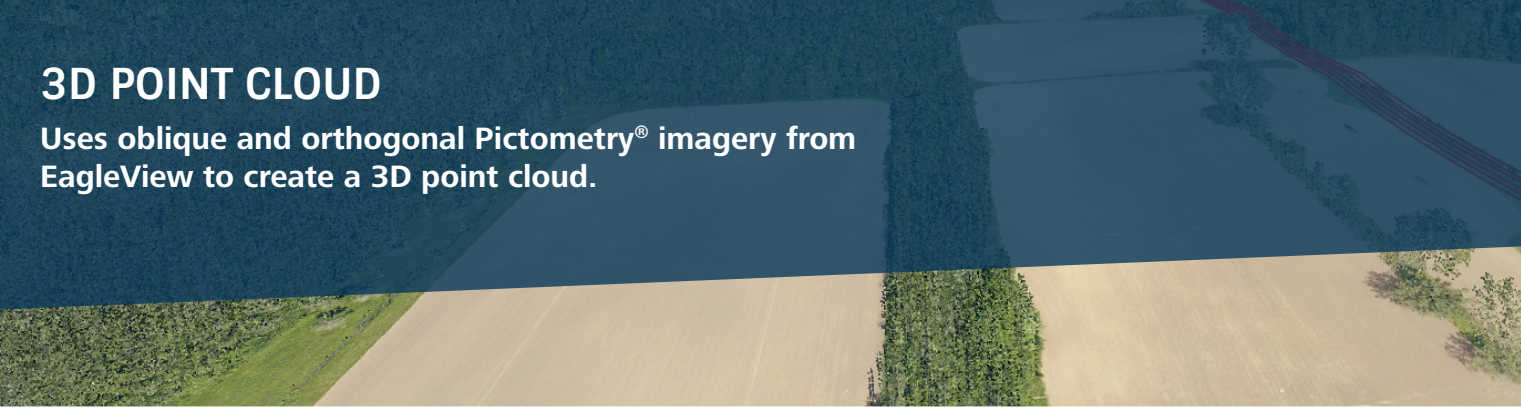
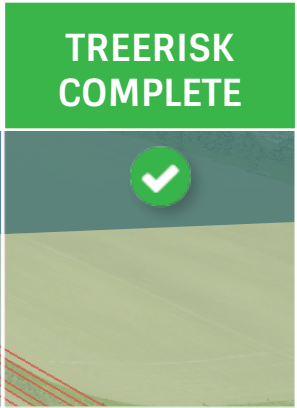
3D POINT CLOUD

Uses oblique and orthogonal Pictometry® imagery from EagleView to create a 3D point cloud.

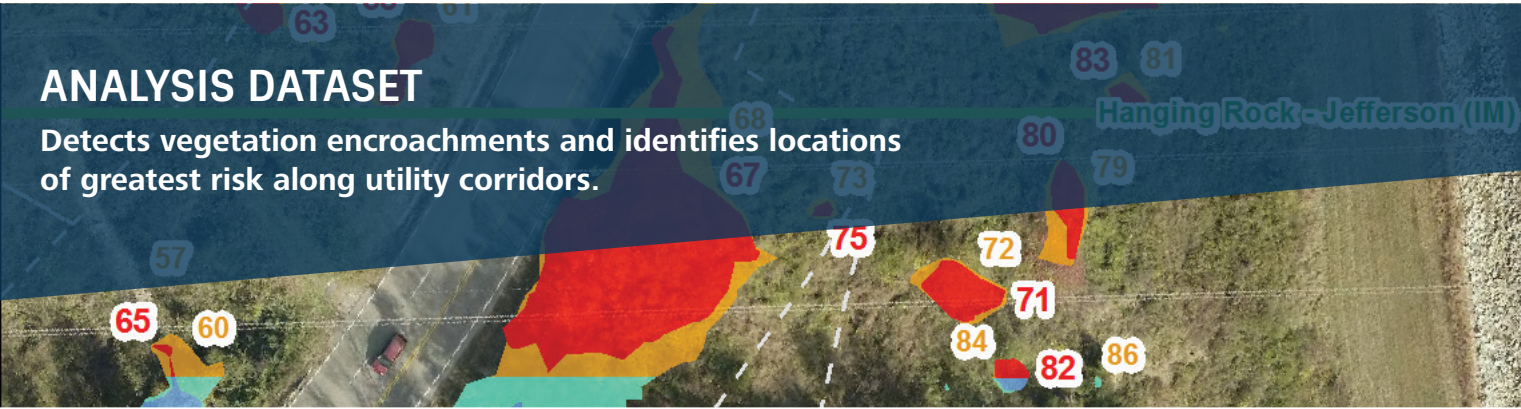
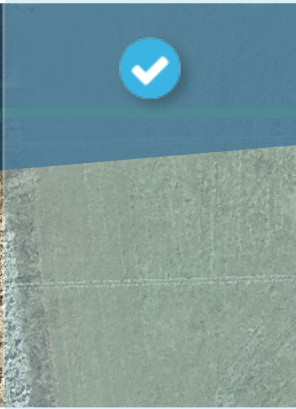
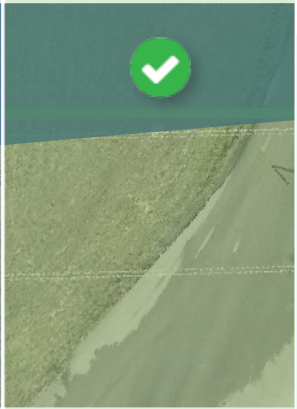
ANALYSIS DATASET

Detects vegetation encroachments and identifies locations of greatest risk along utility corridors.

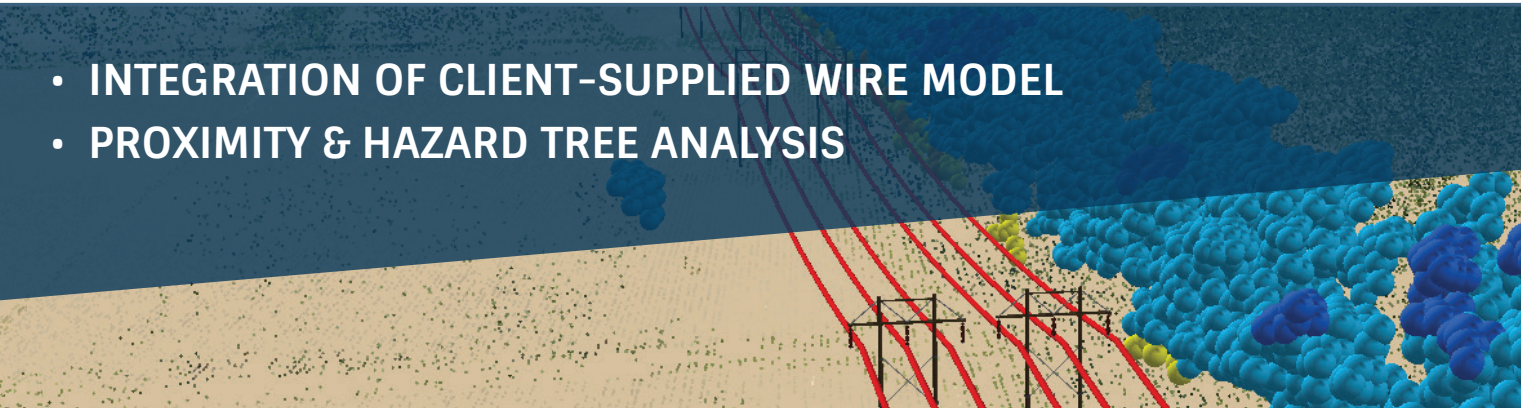
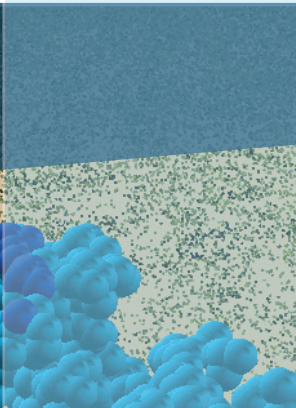
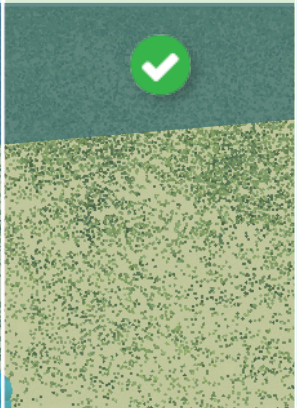
3D POINT CLOUD & ANALYSIS DATASET

TreeRisk was designed with vegetation managers in mind to indicate high-risk areas. Photorealistic models and data can confirm where trees might fall or grow into the wires and cause power outages. The image-based 3D point cloud in TreeRisk enables vegetation managers to view utility corridors as they actually exist.
