# EagleView Inform™

## Advanced for Solar

123 Blue St.  
Palo Alto, CA 94306

September 13, 2019  
 Property Address:  
 123 Blue St. Palo Alto, CA 94306  
 Report: 30314454

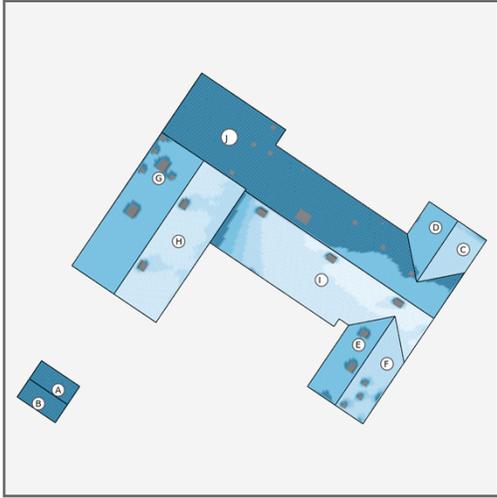
# Annual Solar Values

TSRF

Roof ID	SAV %	TSRF %
A	39	31
B	17	16
C	93	77
D	93	60
E	86	56
F	88	72
G	90	58
H	95	78
I	89	78
J	74	44

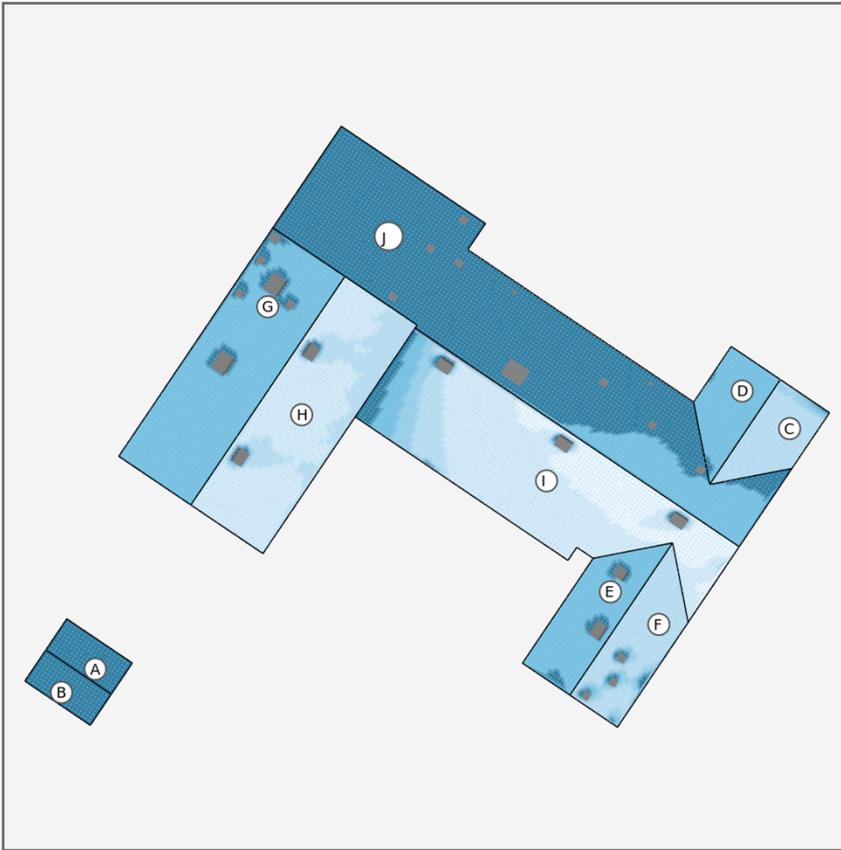
# Roof Summary

The TSRF heatmap has been overlaid on the image. This page is meant as a tool to enable module level design.

TSRF

Roof ID	Pitch °	Azimuth °	SAV %	May-Oct SAV %	Nov-Apr SAV %	TSRF %
A	14	34	39	61	17	31
B	14	214	17	29	6	16
C	23	124	93	95	92	77
D	23	304	93	95	90	60
E	23	304	86	90	82	56
F	23	124	88	91	86	72
G	23	304	90	92	88	58
H	23	124	95	95	94	78
I	23	214	89	89	89	78
J	23	34	74	79	68	44

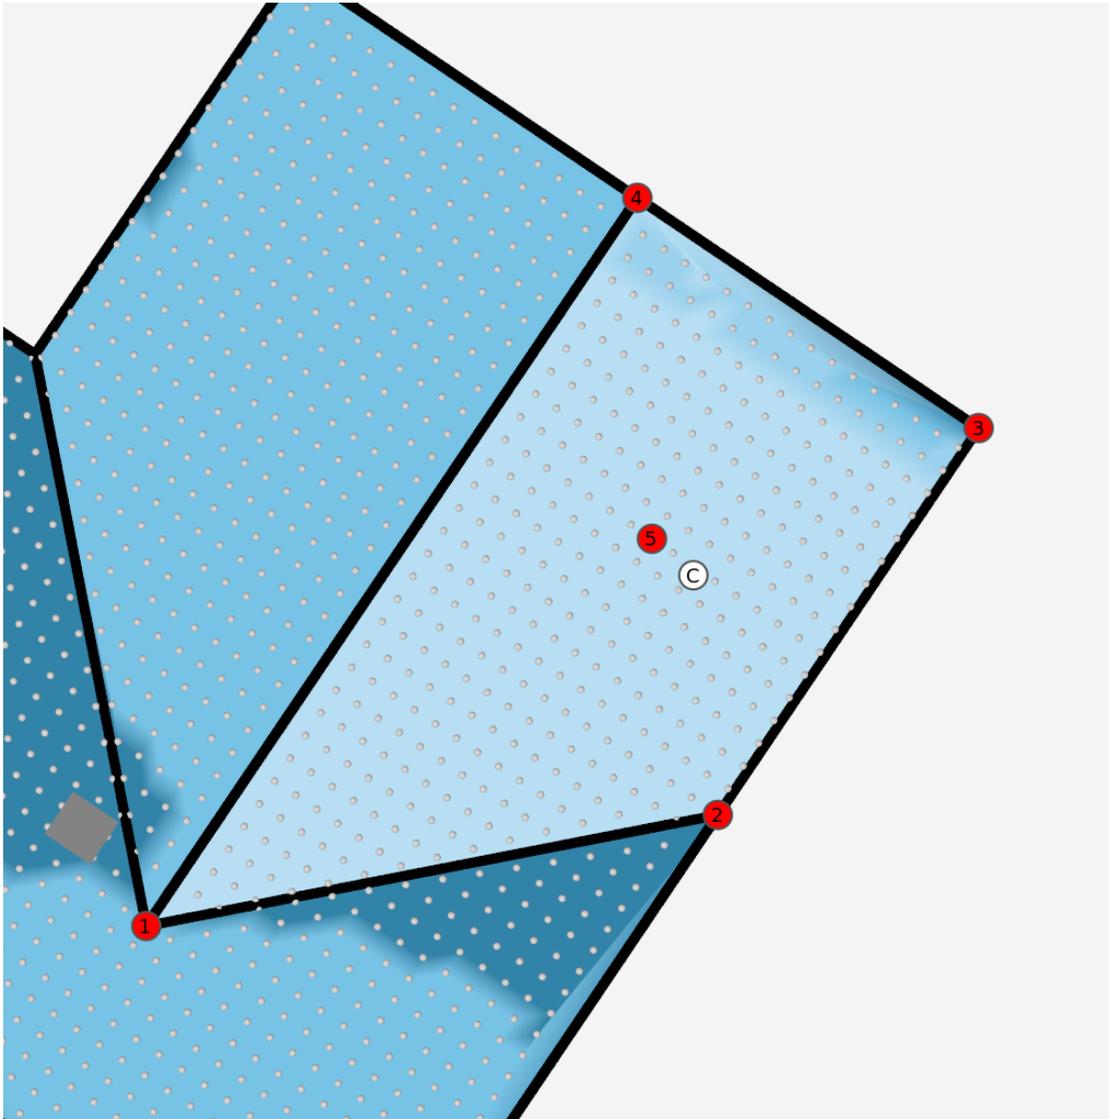
## FACET C DETAIL

TSRF. Red indicators refer to skyline views shown on the following page(s).

Month	SAV %	TOF %	TSRF %
January	92	78	72
February	91	78	71
March	94	80	75
April	96	83	80
May	95	88	84
June	94	91	86

Month	SAV %	TOF %	TSRF %
July	95	89	85
August	96	84	81
September	96	78	75
October	90	77	69
November	92	78	72
December	88	80	70

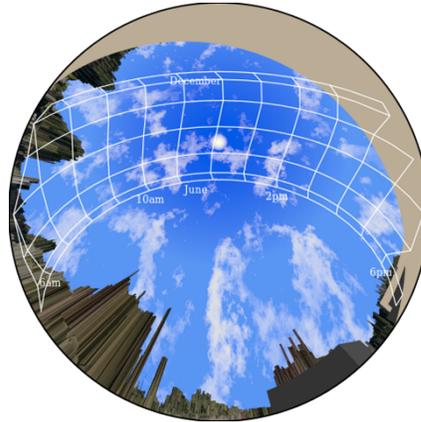
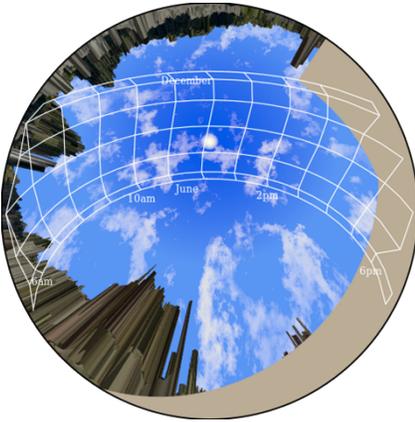
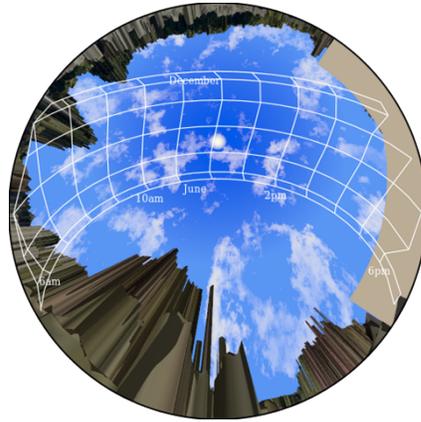
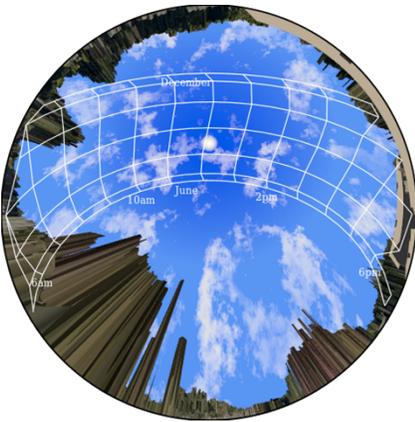
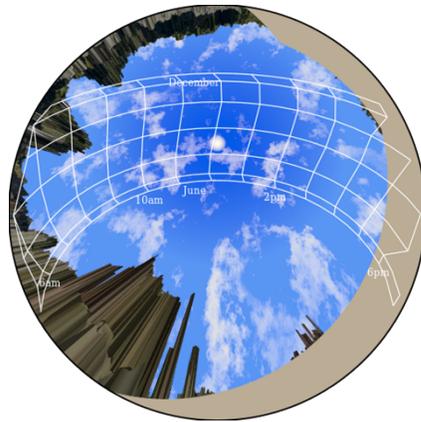
## Facet C - skyline views

The images here correspond to the previous facet detail page. They show a view looking out towards the sky to allow you to see any shade causing obstructions that would appear from the roof surface. The label on the images match the locations on the roof facet, allowing you to see obstruction views from the corners, and center point, of each facet.

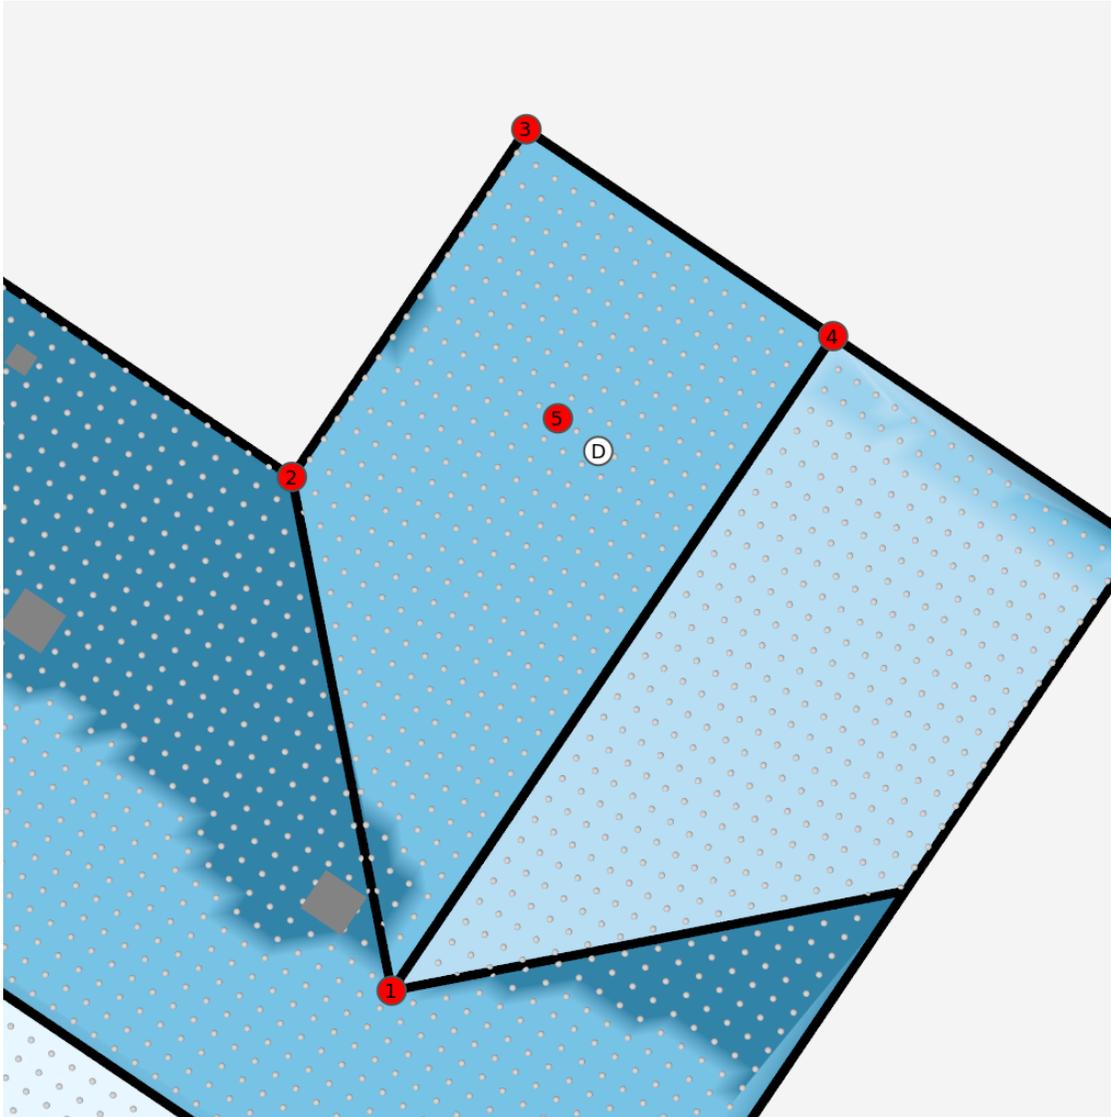
## FACET D DETAIL

TSRF. Red indicators refer to skyline views shown on the following page(s).

Month	SAV %	TOF %	TSRF %
January	87	47	40
February	91	54	49
March	95	60	57
April	97	71	69
May	97	83	81
June	94	88	83

Month	SAV %	TOF %	TSRF %
July	95	86	82
August	96	79	76
September	96	62	60
October	93	54	50
November	88	45	40
December	82	43	36

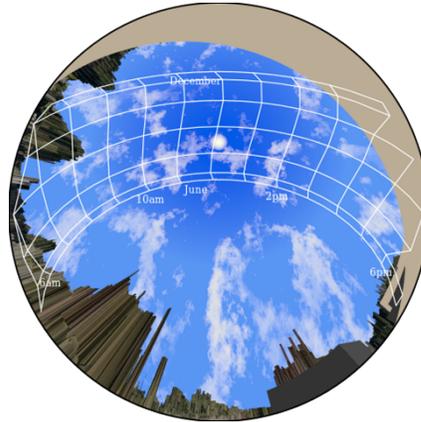
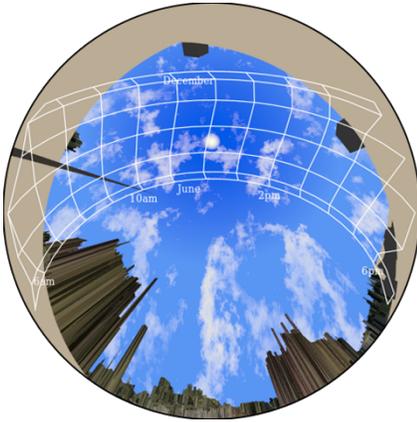
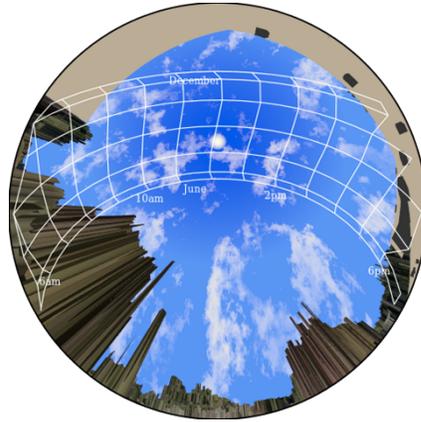
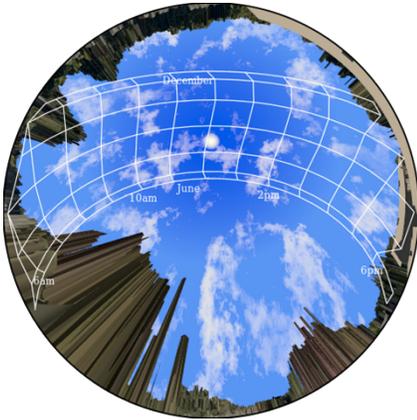
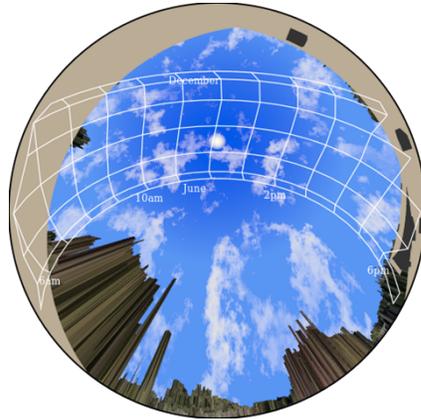
## Facet D - skyline views

The images here correspond to the previous facet detail page. They show a view looking out towards the sky to allow you to see any shade causing obstructions that would appear from the roof surface. The label on the images match the locations on the roof facet, allowing you to see obstruction views from the corners, and center point, of each facet.

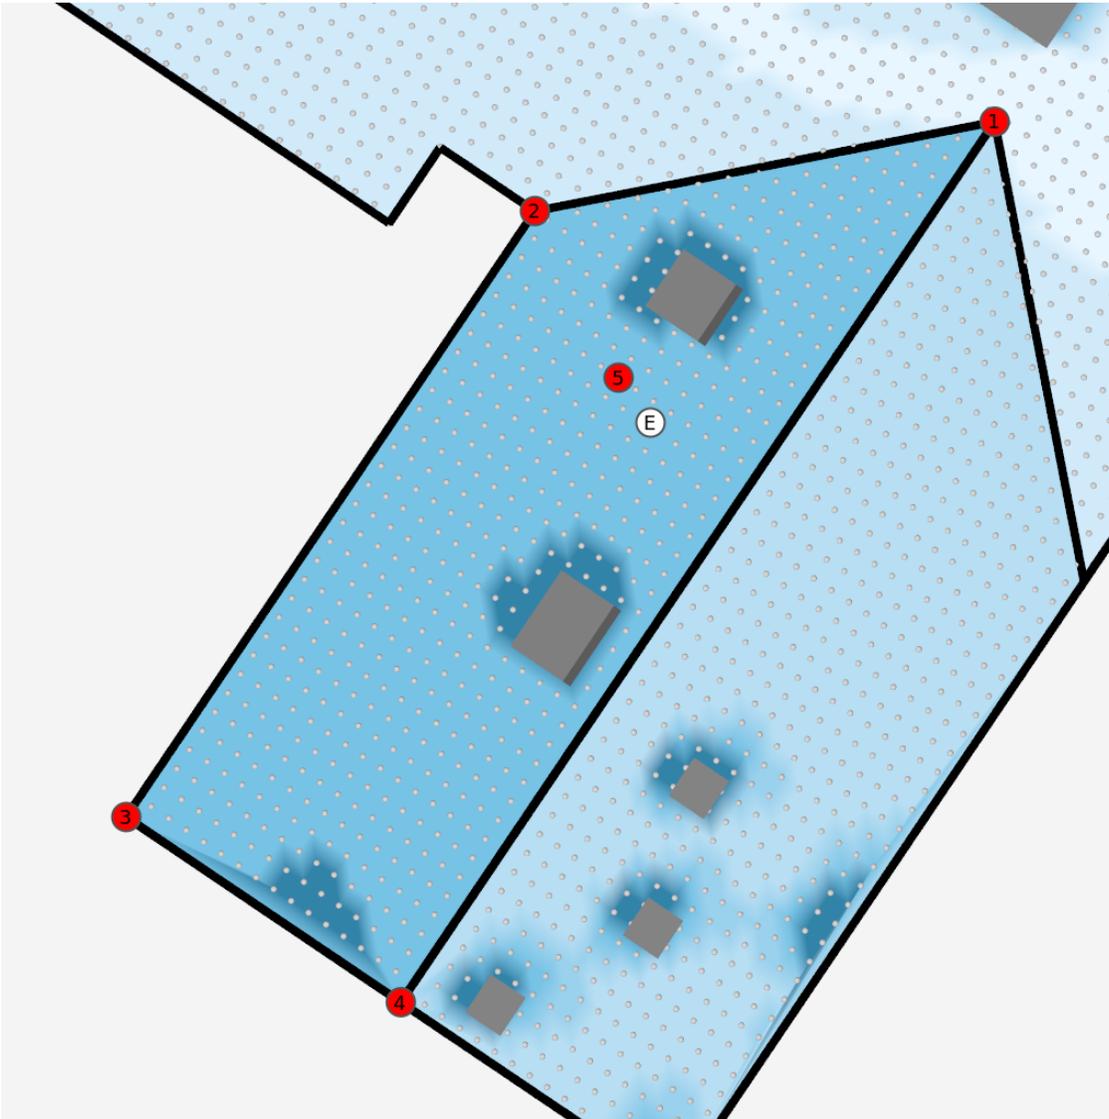
## FACET E DETAIL

TSRF. Red indicators refer to skyline views shown on the following page(s).

Month	SAV %	TOF %	TSRF %
January	77	47	36
February	81	54	43
March	88	60	53
April	92	71	66
May	93	83	78
June	92	88	81

Month	SAV %	TOF %	TSRF %
July	92	86	79
August	92	79	73
September	90	62	56
October	83	54	45
November	79	45	36
December	73	43	32

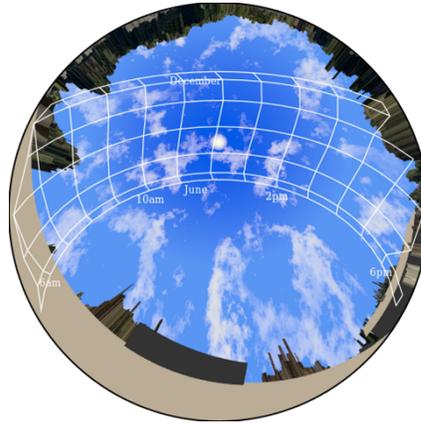
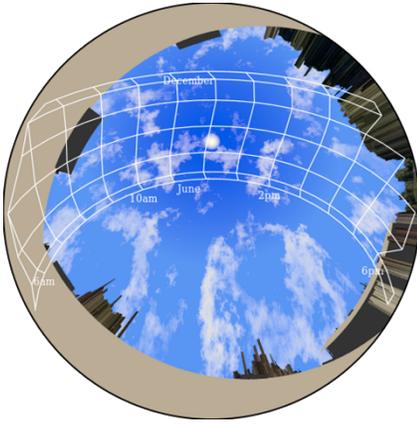
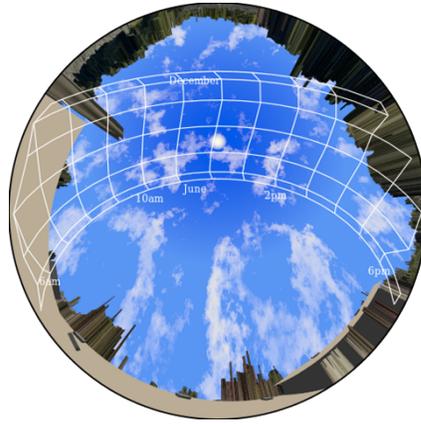
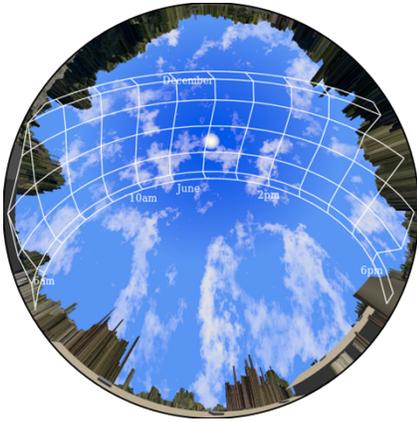
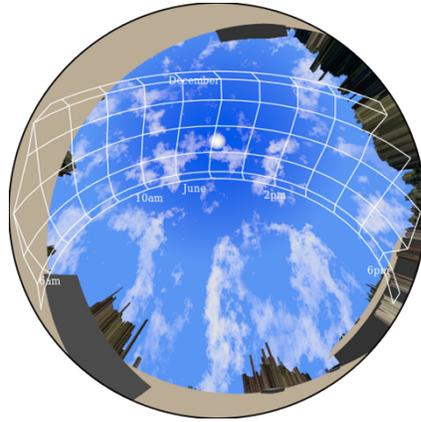
## Facet E - skyline views

The images here correspond to the previous facet detail page. They show a view looking out towards the sky to allow you to see any shade causing obstructions that would appear from the roof surface. The label on the images match the locations on the roof facet, allowing you to see obstruction views from the corners, and center point, of each facet.

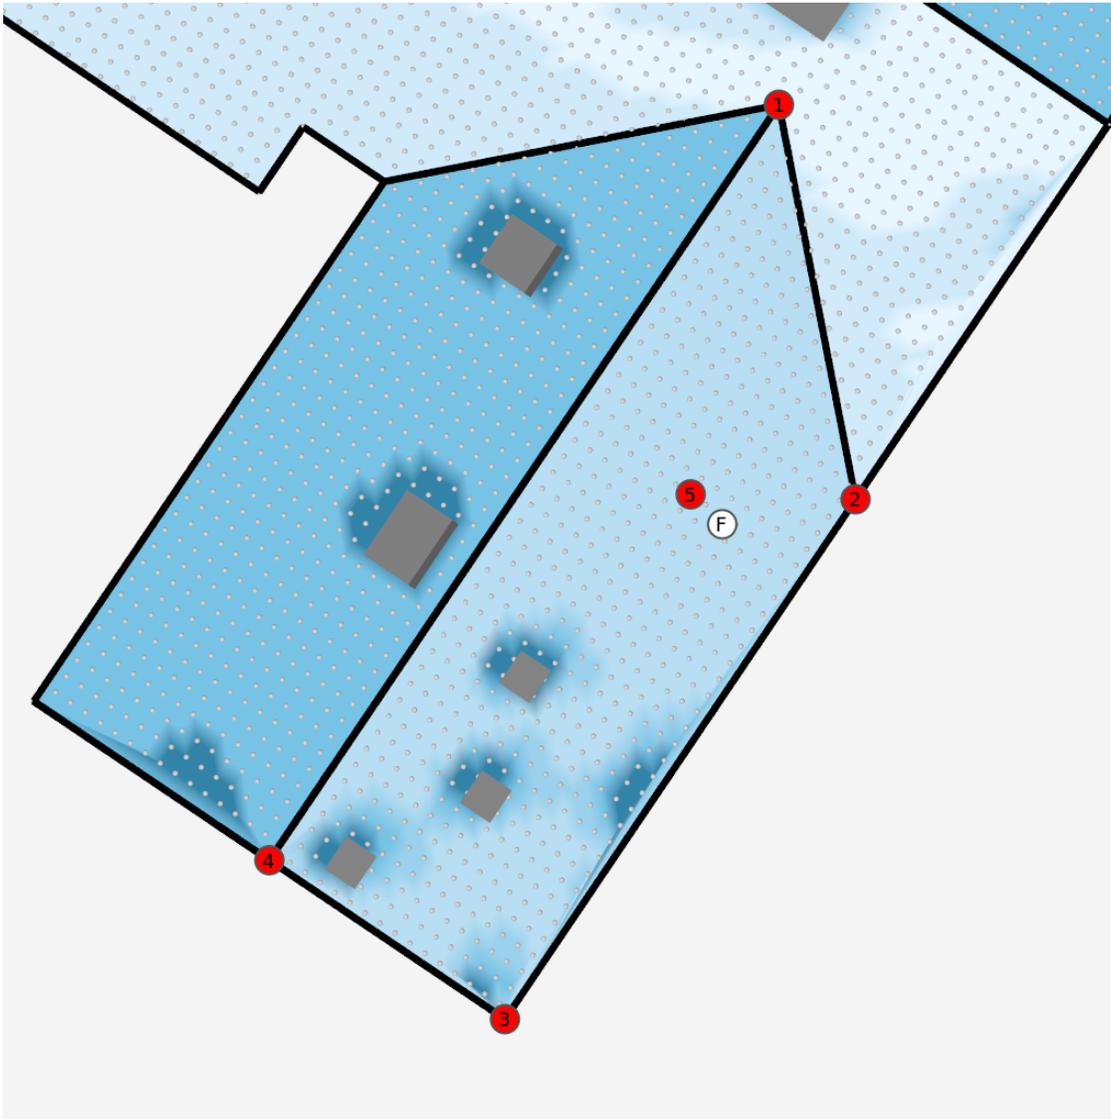
## FACET F DETAIL

TSRF. Red indicators refer to skyline views shown on the following page(s).

Month	SAV %	TOF %	TSRF %
January	83	78	65
February	89	78	70
March	86	80	68
April	92	83	77
May	92	88	81
June	91	91	83

Month	SAV %	TOF %	TSRF %
July	92	89	82
August	93	84	78
September	89	78	69
October	88	77	67
November	84	78	66
December	80	80	64

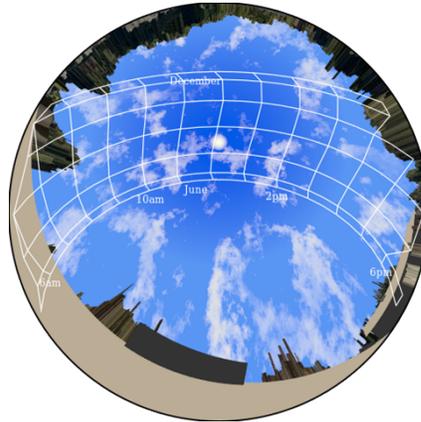
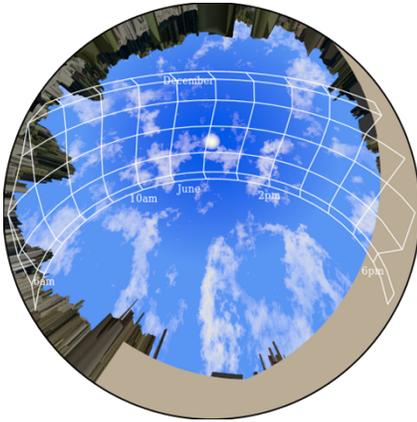
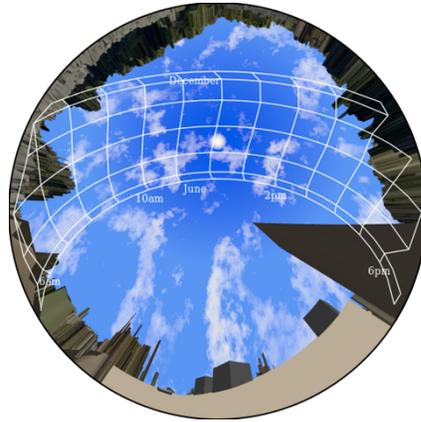
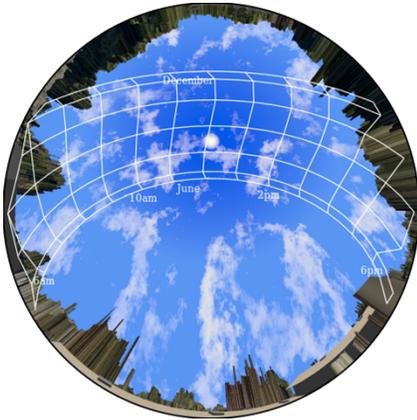
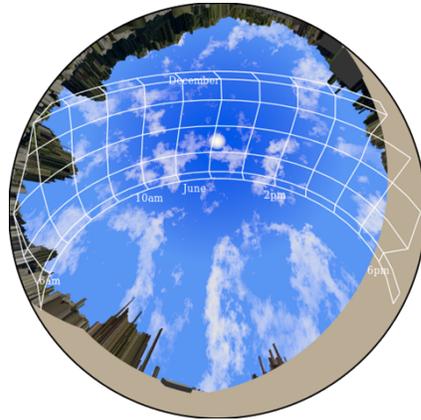
## Facet F - skyline views

The images here correspond to the previous facet detail page. They show a view looking out towards the sky to allow you to see any shade causing obstructions that would appear from the roof surface. The label on the images match the locations on the roof facet, allowing you to see obstruction views from the corners, and center point, of each facet.

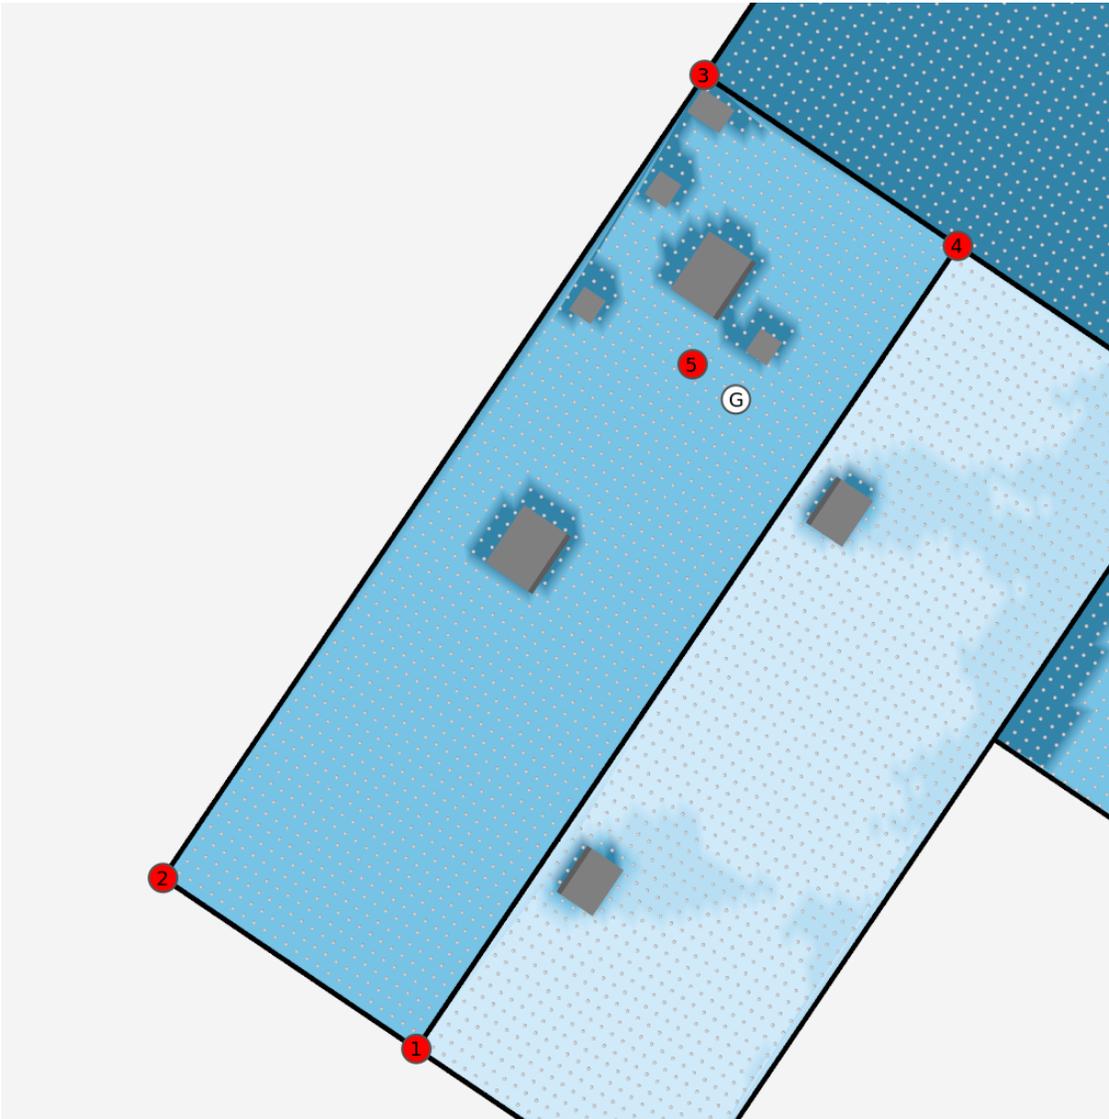
## FACET G DETAIL

TSRF. Red indicators refer to skyline views shown on the following page(s).

Month	SAV %	TOF %	TSRF %
January	86	47	40
February	88	54	47
March	92	60	55
April	93	71	66
May	93	83	77
June	91	88	80

Month	SAV %	TOF %	TSRF %
July	91	86	79
August	92	79	73
September	92	62	58
October	90	54	49
November	87	45	39
December	85	43	37

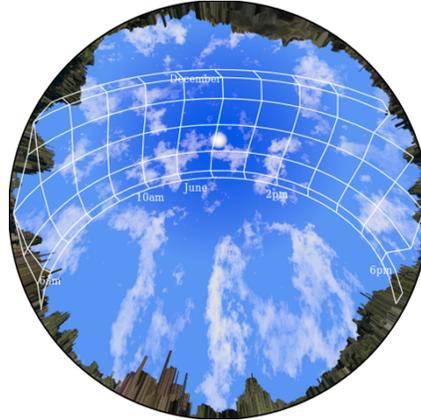
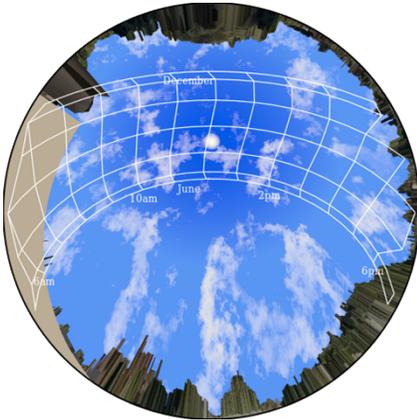
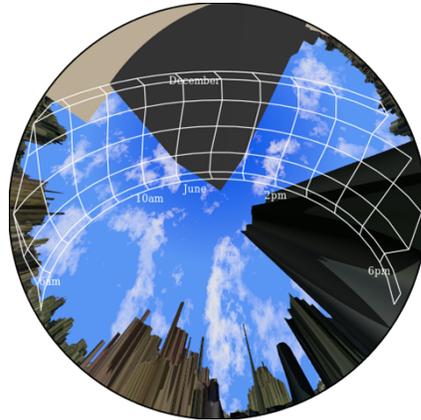
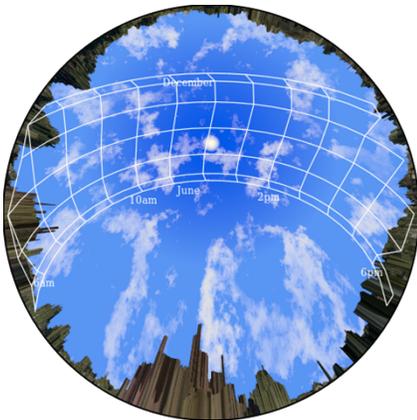
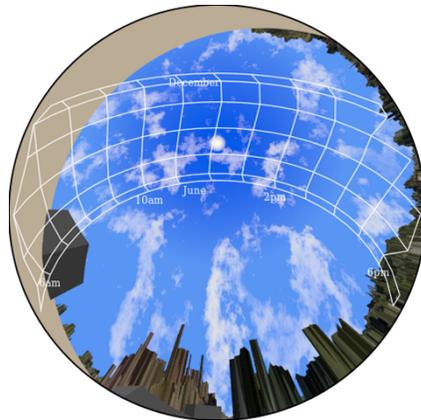
## Facet G - skyline views

The images here correspond to the previous facet detail page. They show a view looking out towards the sky to allow you to see any shade causing obstructions that would appear from the roof surface. The label on the images match the locations on the roof facet, allowing you to see obstruction views from the corners, and center point, of each facet.

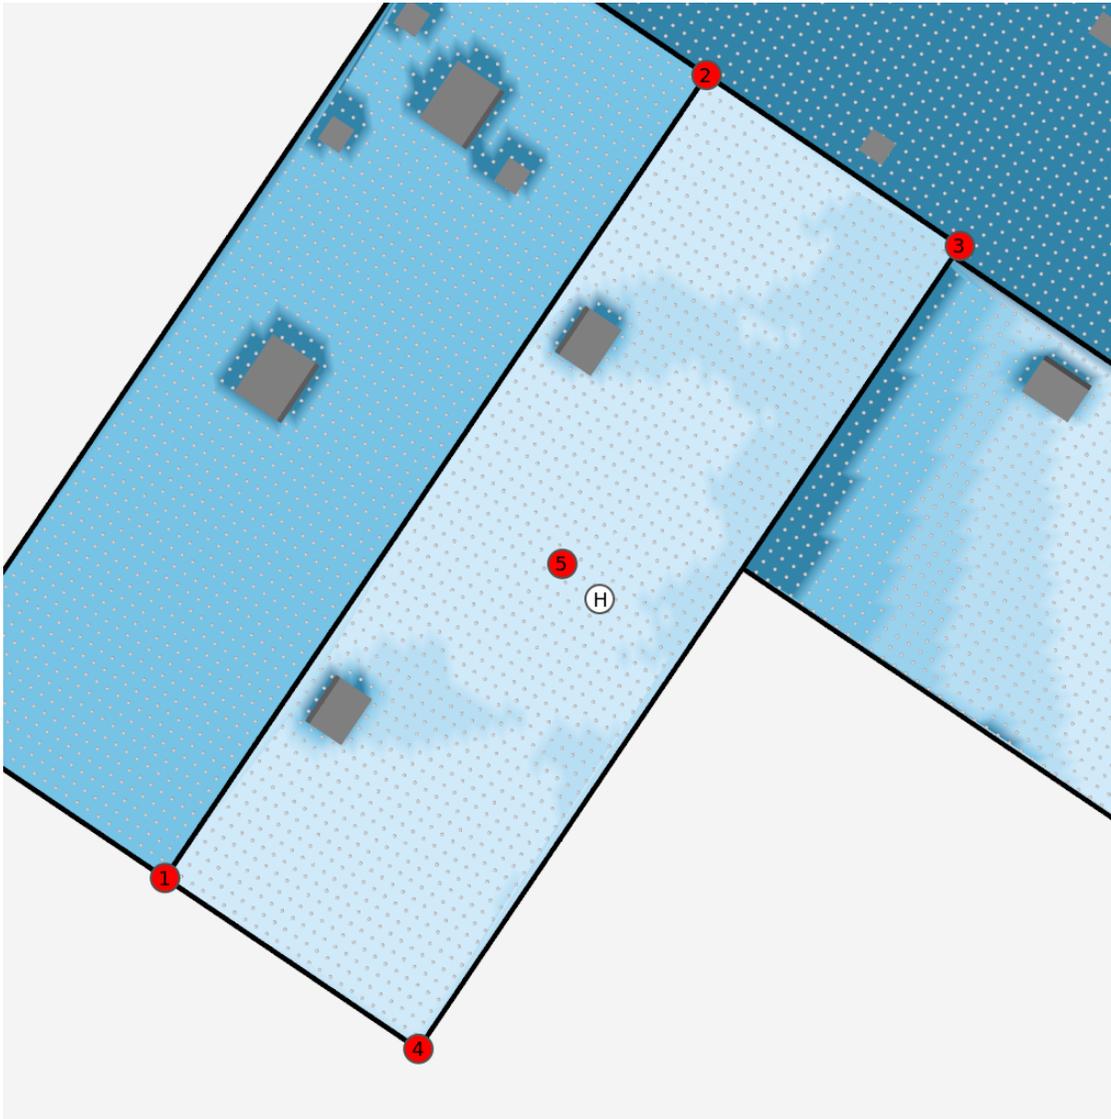
## FACET H DETAIL

TSRF. Red indicators refer to skyline views shown on the following page(s).

Month	SAV %	TOF %	TSRF %
January	95	78	74
February	95	78	74
March	96	80	76
April	95	83	79
May	95	88	83
June	94	91	85

Month	SAV %	TOF %	TSRF %
July	95	89	84
August	95	84	80
September	96	78	75
October	94	77	72
November	95	78	74
December	92	80	73

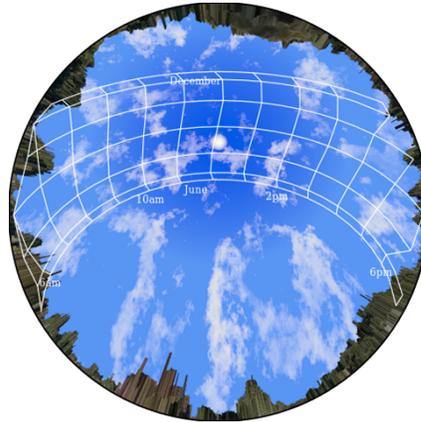
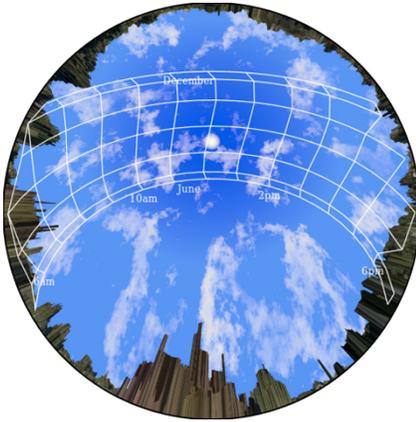
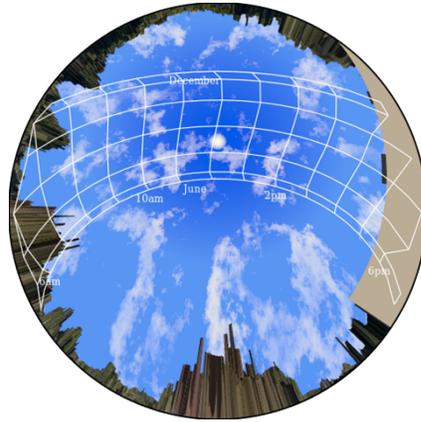
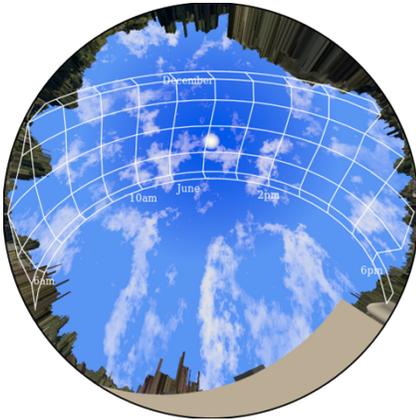
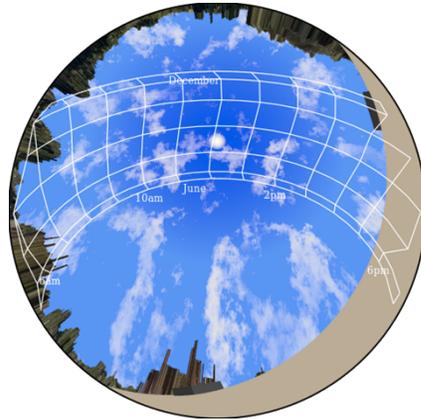
## Facet H - skyline views

The images here correspond to the previous facet detail page. They show a view looking out towards the sky to allow you to see any shade causing obstructions that would appear from the roof surface. The label on the images match the locations on the roof facet, allowing you to see obstruction views from the corners, and center point, of each facet.

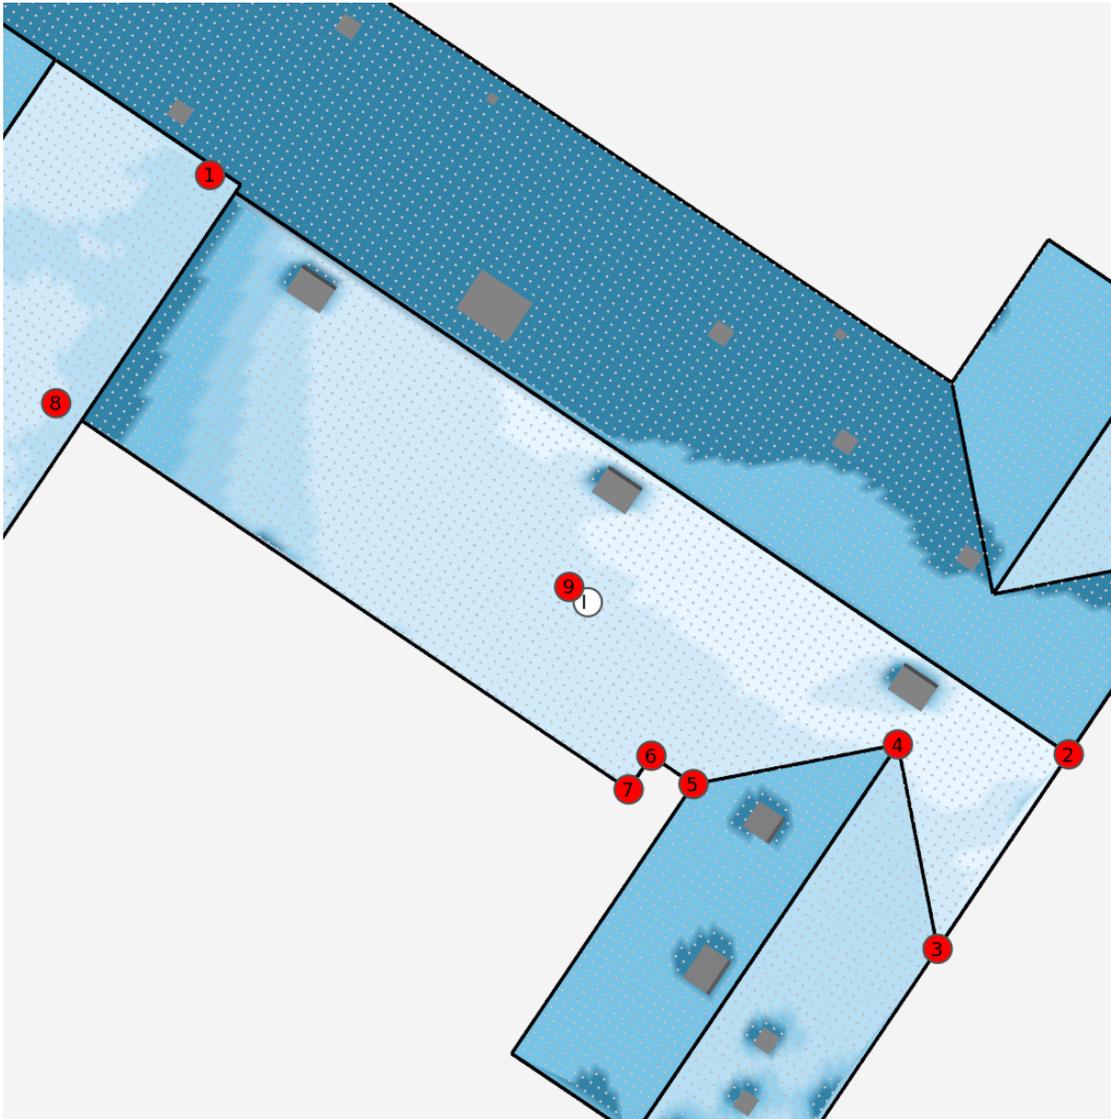
## FACET I DETAIL

TSRF. Red indicators refer to skyline views shown on the following page(s).

Month	SAV %	TOF %	TSRF %
January	88	88	77
February	91	85	77
March	90	83	74
April	90	86	77
May	89	91	81
June	88	91	80

Month	SAV %	TOF %	TSRF %
July	88	92	81
August	90	91	81
September	90	84	76
October	90	84	76
November	89	86	76
December	85	89	75

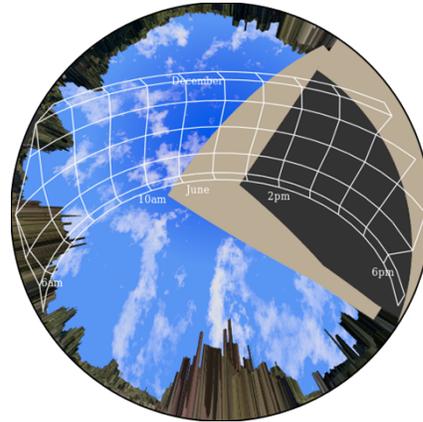
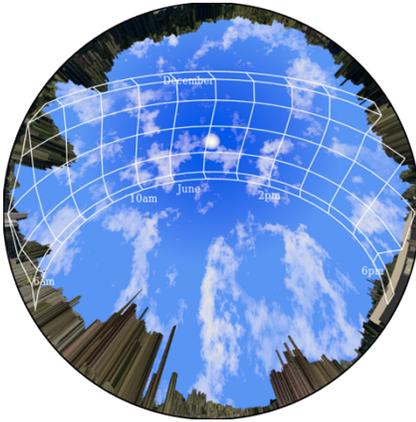
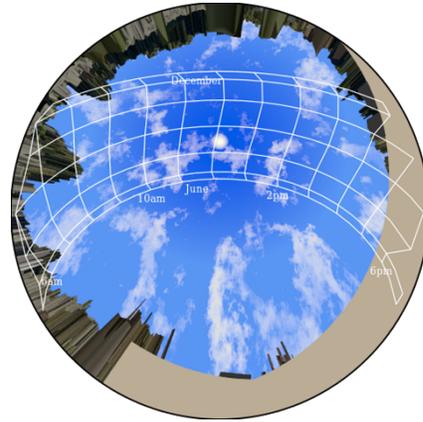
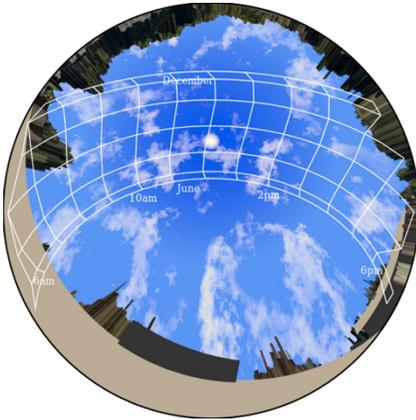
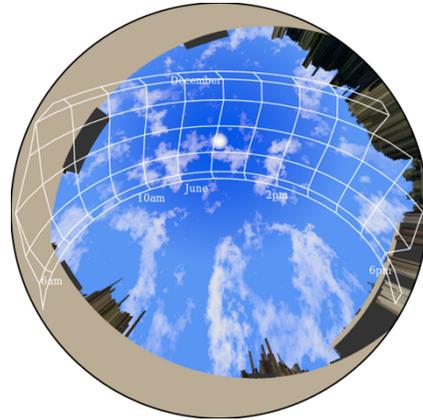
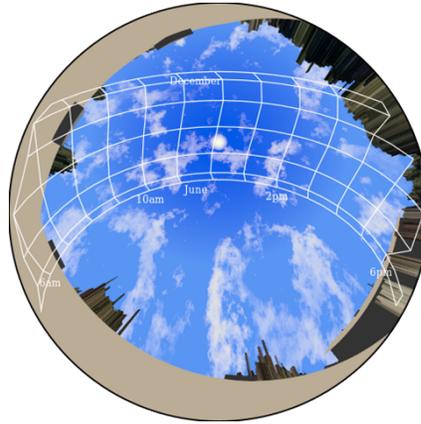
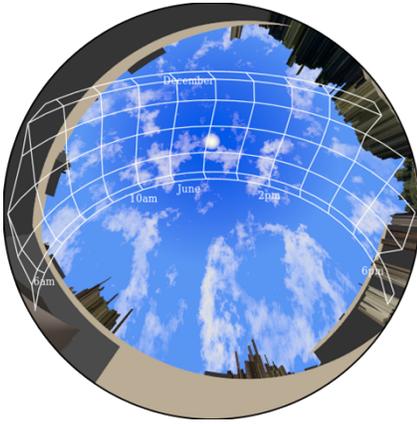
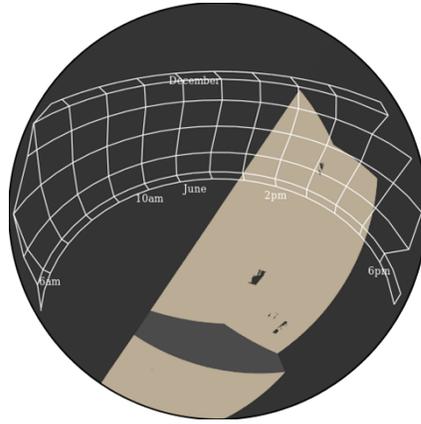
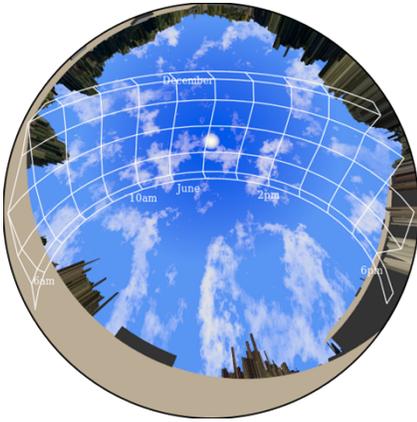
## Facet I - skyline views

The images here correspond to the previous facet detail page. They show a view looking out towards the sky to allow you to see any shade causing obstructions that would appear from the roof surface. The label on the images match the locations on the roof facet, allowing you to see obstruction views from the corners, and center point, of each facet.

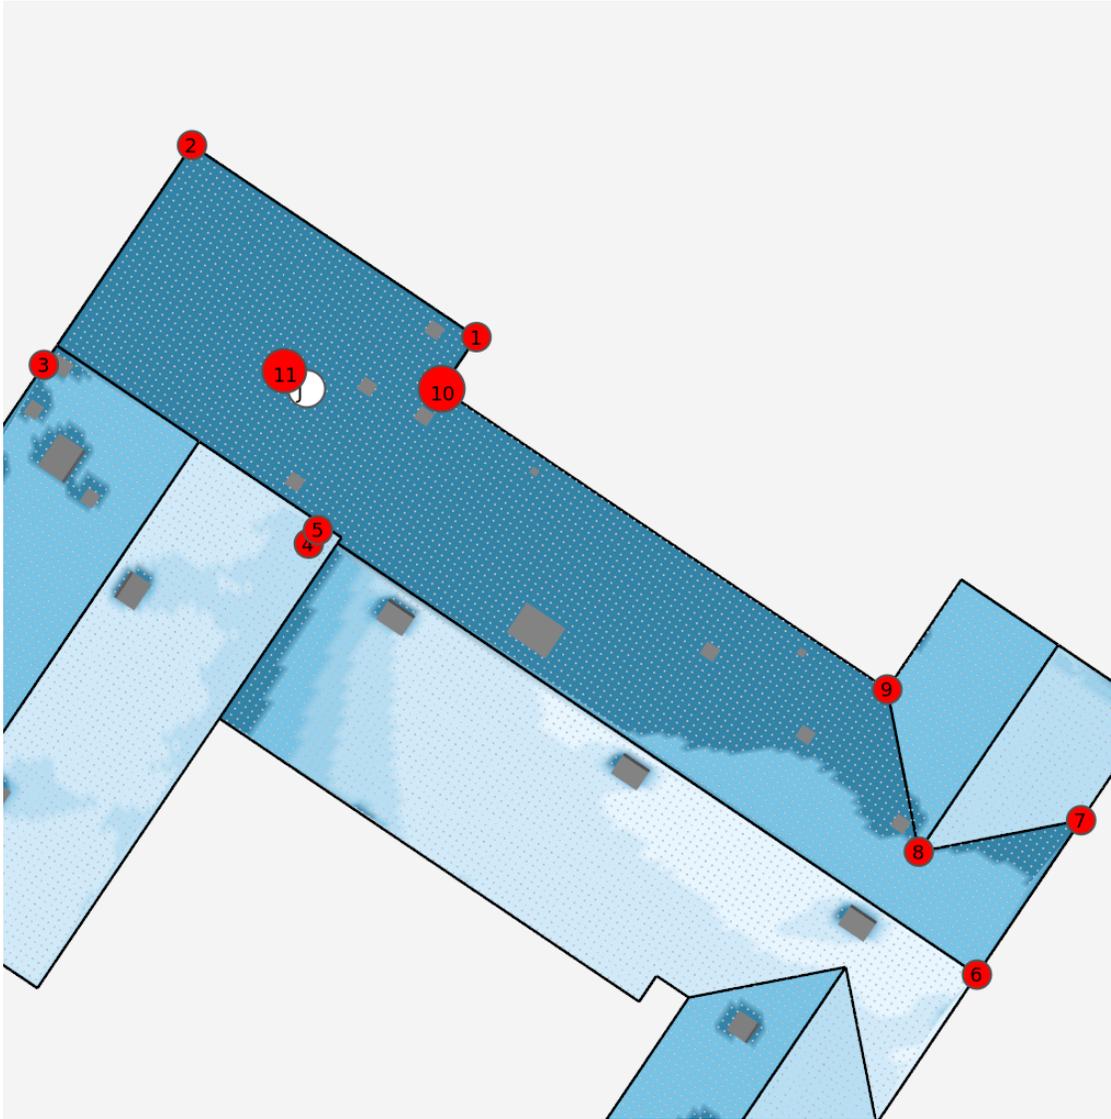
## FACET J DETAIL

TSRF. Red indicators refer to skyline views shown on the following page(s).

Month	SAV %	TOF %	TSRF %
January	63	36	23
February	68	46	31
March	77	55	42
April	79	68	54
May	81	80	65
June	82	87	71

Month	SAV %	TOF %	TSRF %
July	82	83	68
August	81	72	58
September	79	56	44
October	70	46	32
November	65	36	24
December	57	34	19

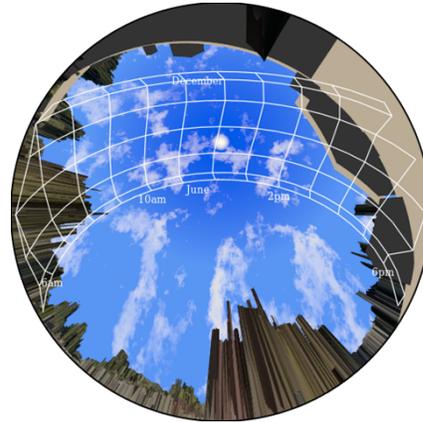
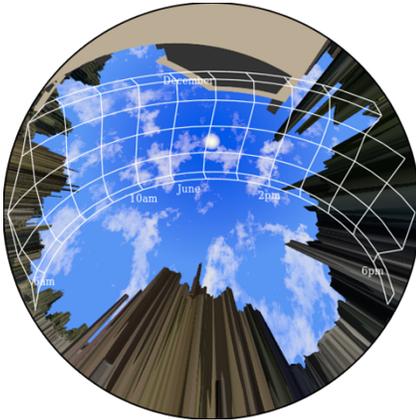
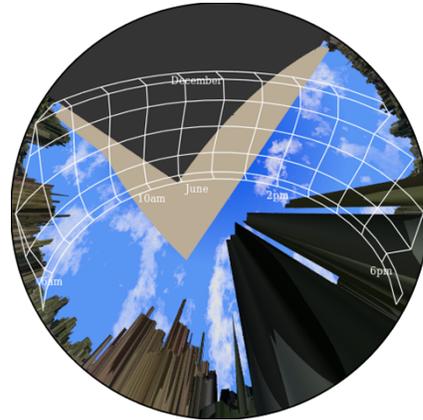
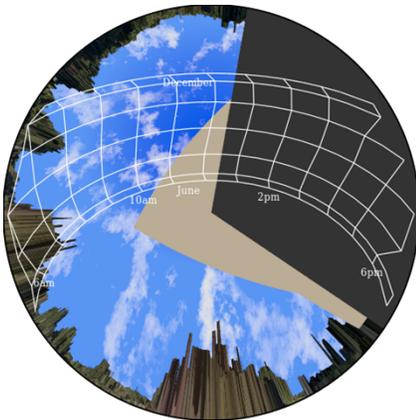
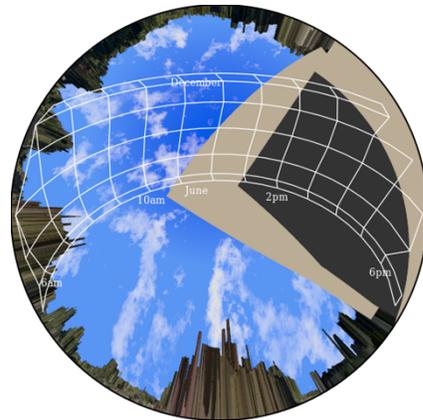
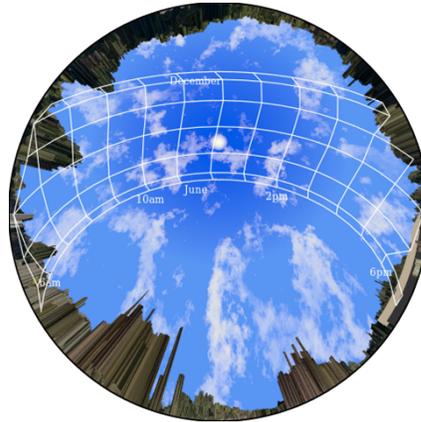
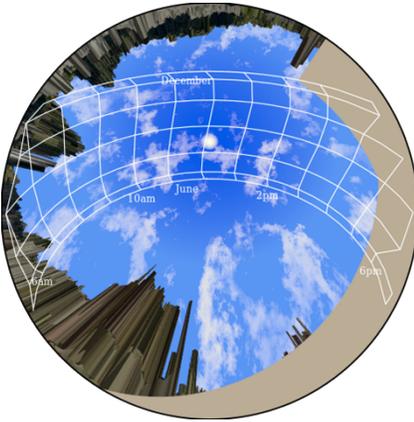
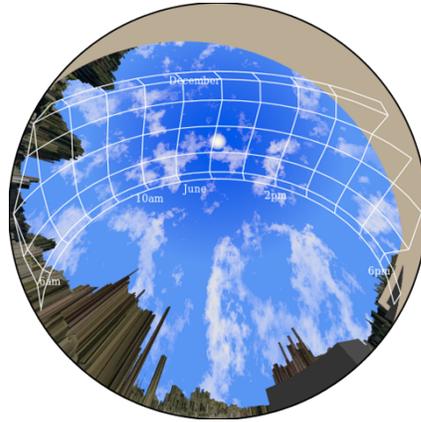
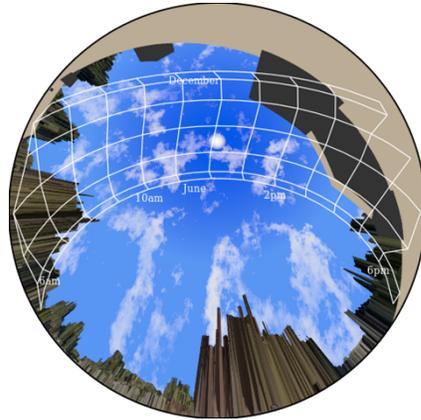
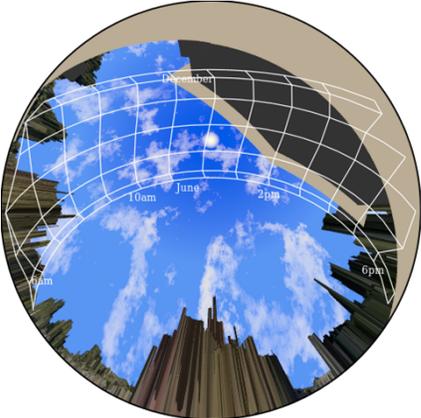
## Facet J - skyline views

The images here correspond to the previous facet detail page. They show a view looking out towards the sky to allow you to see any shade causing obstructions that would appear from the roof surface. The label on the images match the locations on the roof facet, allowing you to see obstruction views from the corners, and center point, of each facet.

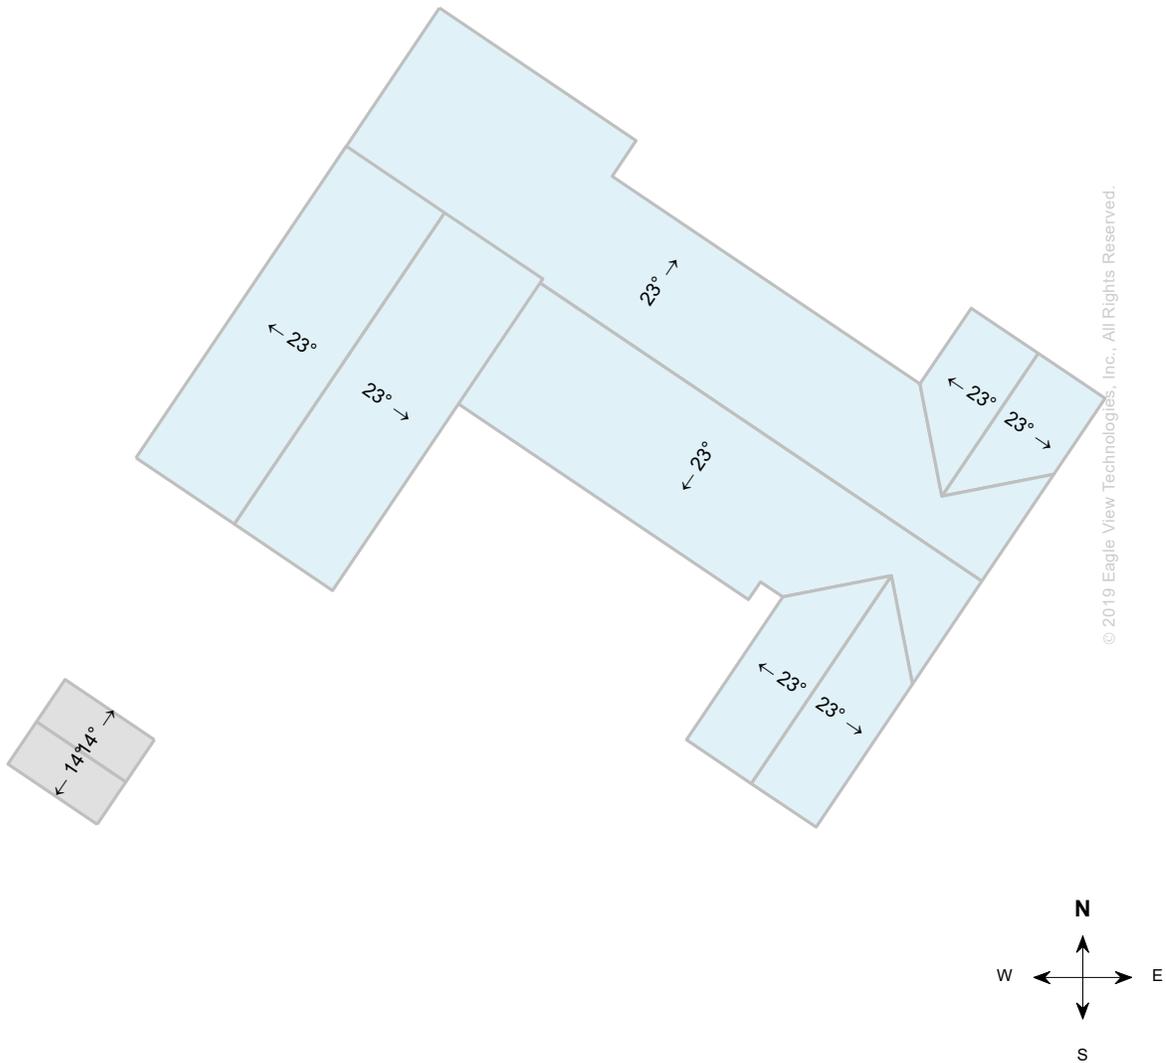
# Pitch

Pitches are labeled for facet areas larger than 20 square feet. In some cases, pitch labels have been removed for readability. Flat facets are labeled 'F'.
