# EagleView Inform™

## Advanced for Solar

123 Blue St.  
Palo Alto, CA 94306

September 13, 2019  
 Property Address:  
 123 Blue St. Palo Alto, CA 94306  
 Report: 30314454

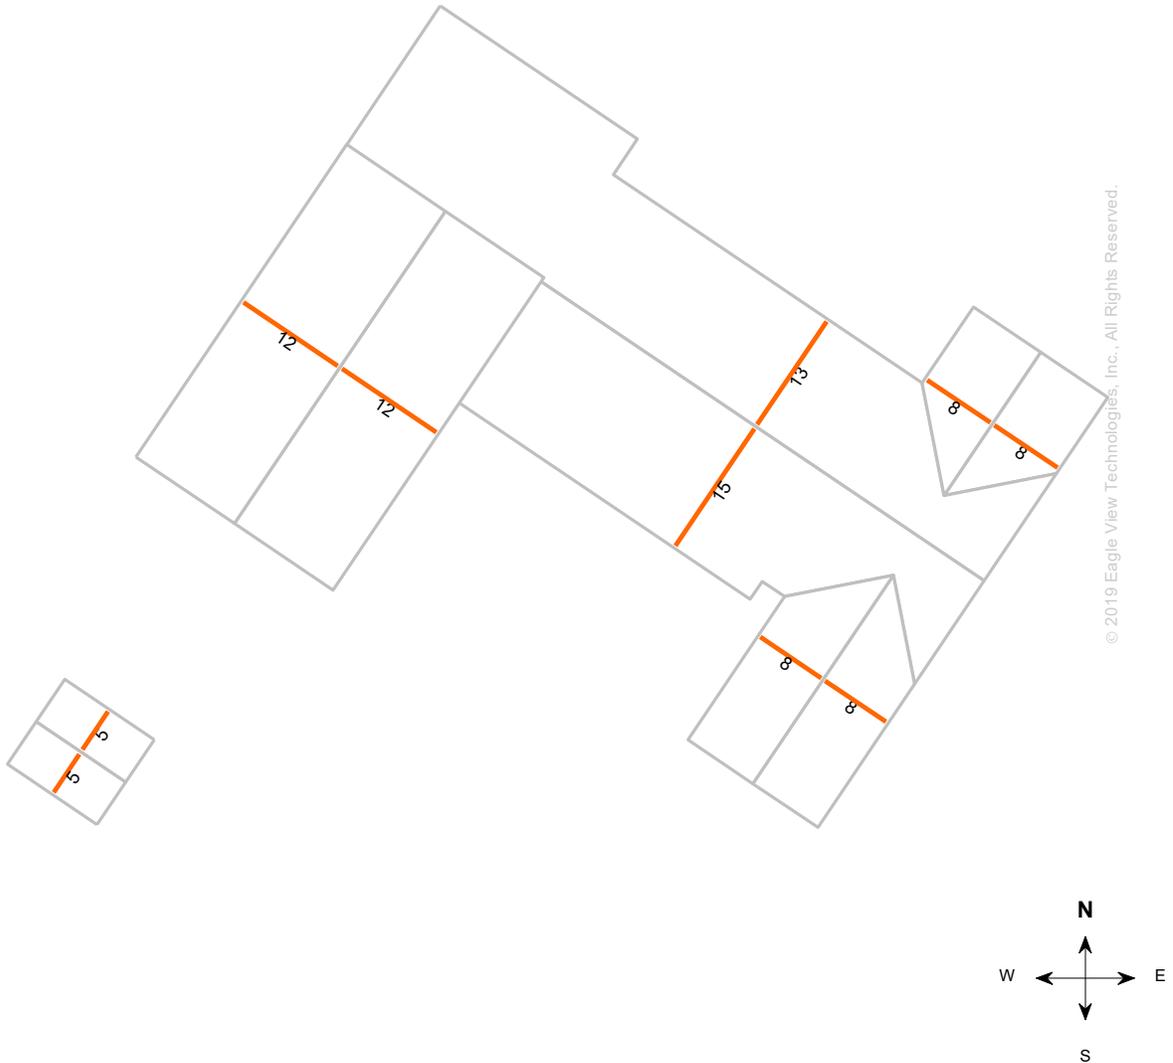
# Rafters

Rafter lengths (rounded to the nearest whole number) over 5 feet. In some cases, segment labels have been removed for readability. Some numbers are prefaced by “+” signs to avoid confusion when rotated (e.g. +6 and +9).

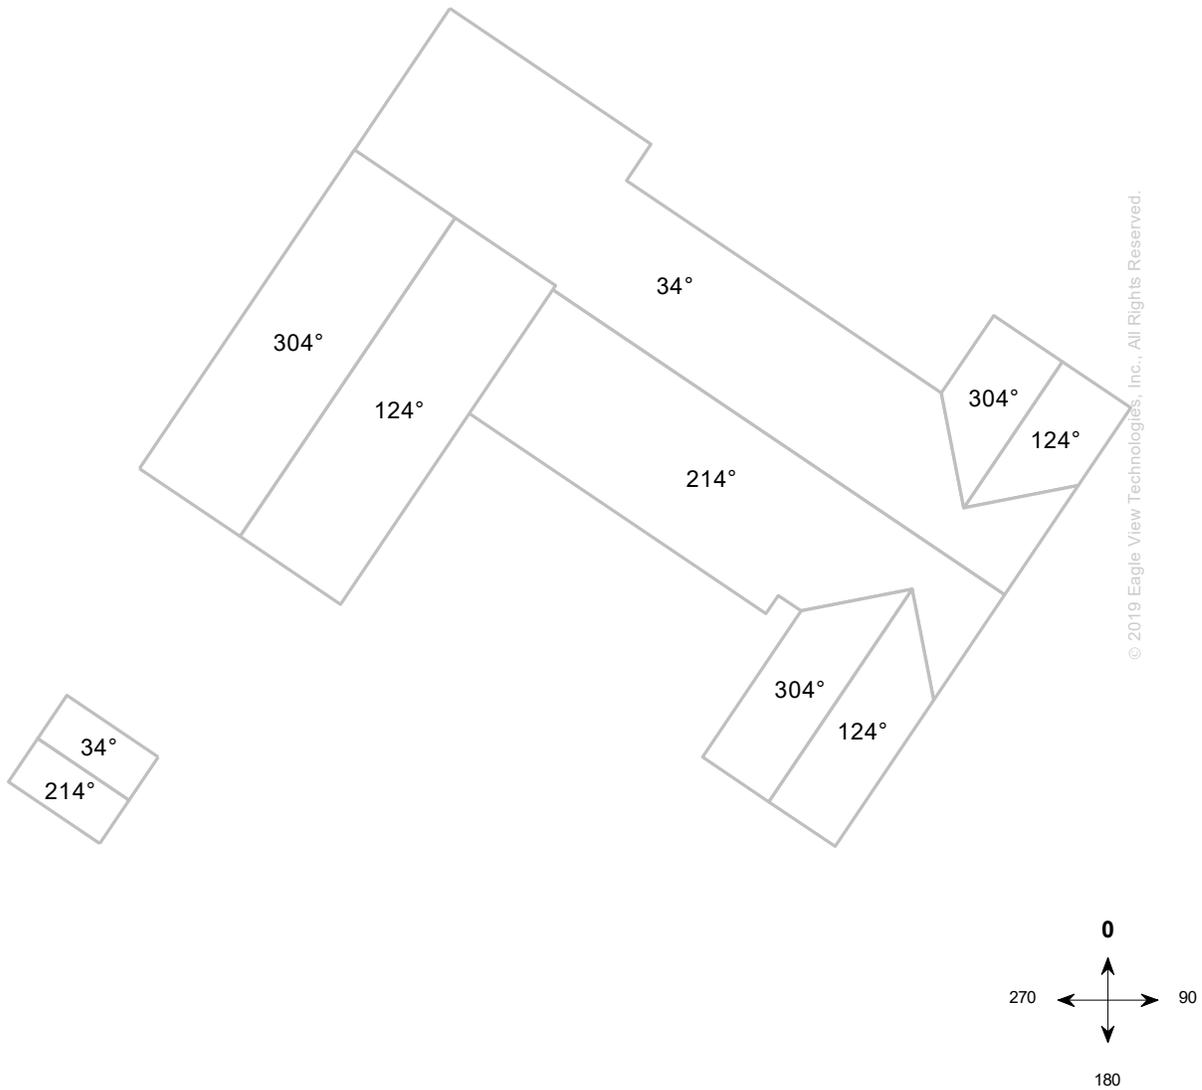
# Azimuth

The azimuth is the orientation of the structure to true north. In this diagram roof facet directions are labeled in degrees, with 0° (360°) as true north. Flat facets are labeled as 'F'.

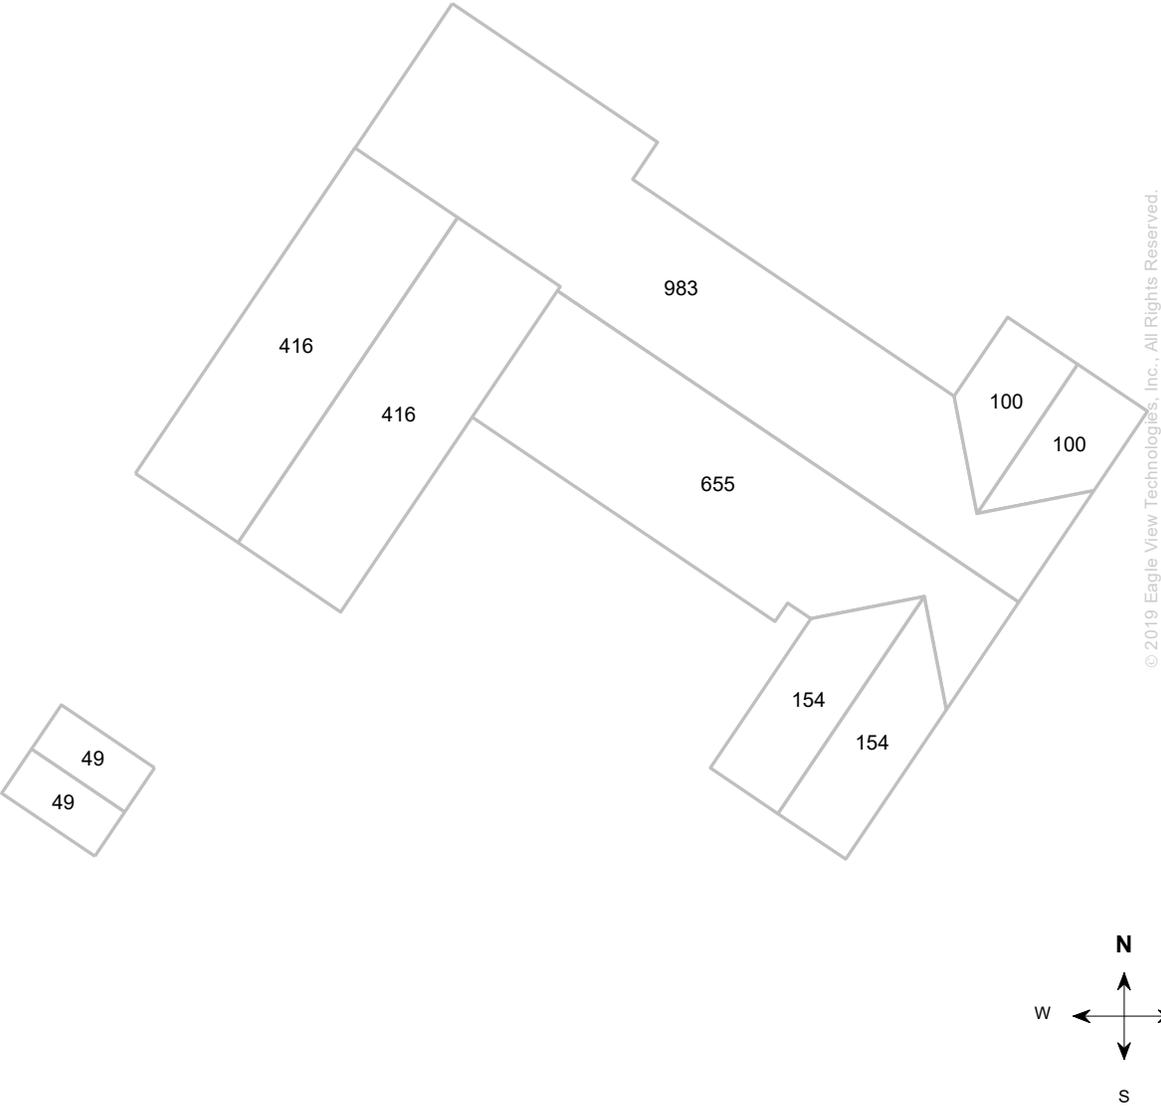
# Area

The area is measured in square feet per roof facet. The values have been rounded to the nearest foot square.

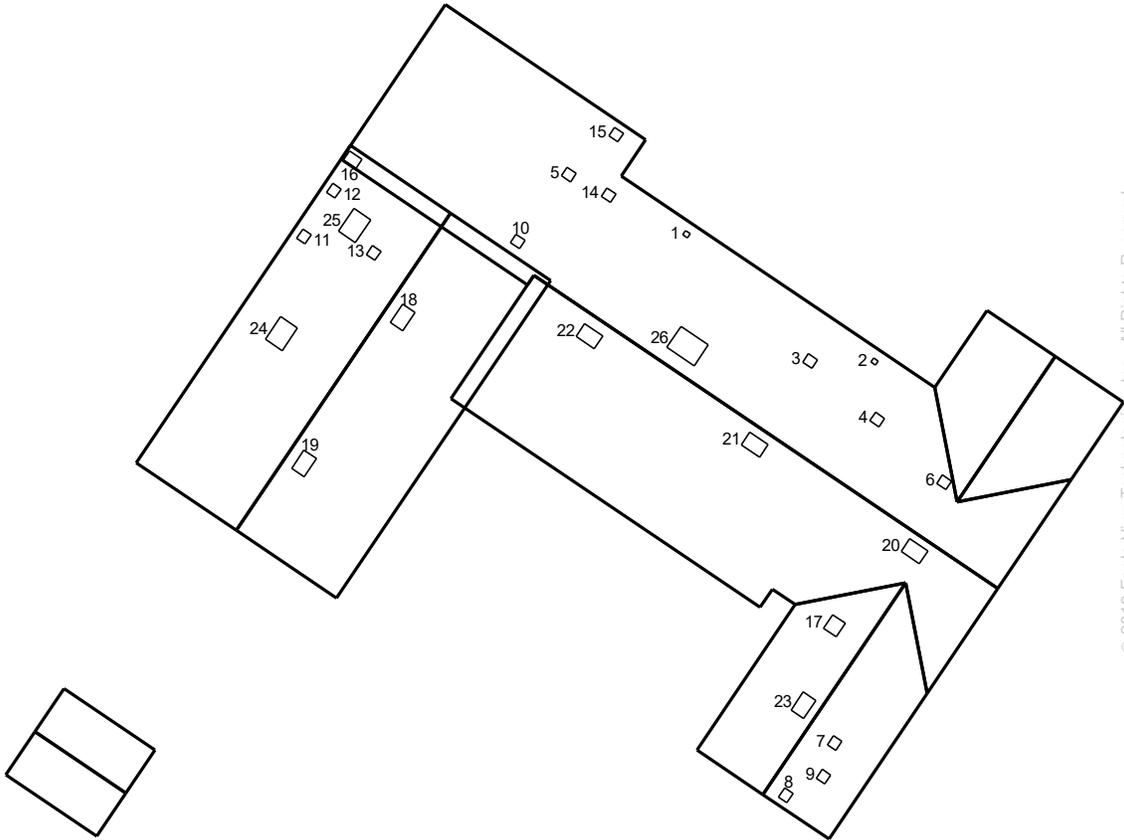
# Penetrations

Area:	3,076 sq ft
Roof Facets:	10
Predominant Pitch:	23°
Number of Stories:	>1
Ridges/Hips:	136 ft
Valleys:	44 ft
Rakes:	150 ft
Eaves:	232 ft
Penetrations:	26
Penetrations Perimeter:	138 ft
Penetrations Area:	53 sq ft
