Property Address

1122 Main St.
Greenville, US 12345

Measurements

October 2, 2019
 1122 Main St.
 Greenville, US 12345
 Report: 123456789

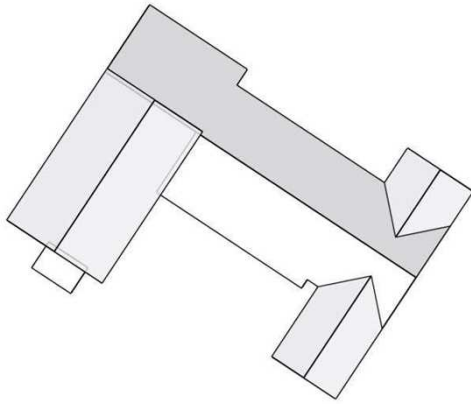
In this 3D model, facets appear as semi-transparent to reveal overhangs.

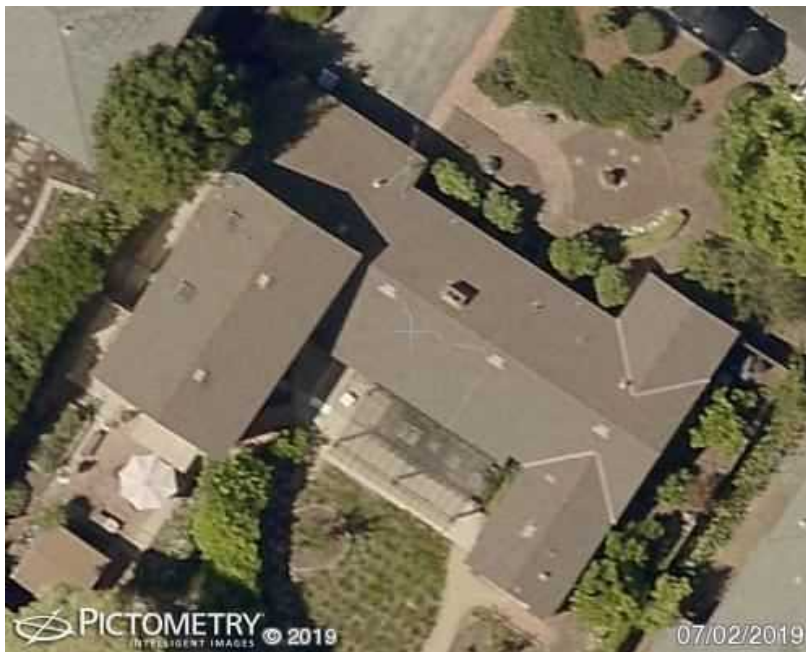
TOP VIEW

These are images of the property taken from multiple angles.
