Total Solar Resource Fraction (TSRF)

10497 1230 W
South Jordan, UT 84095

December 19, 2019
 Property Address:
 1023 Florence Rd Oswego, OR 98321
 Report: 32181797

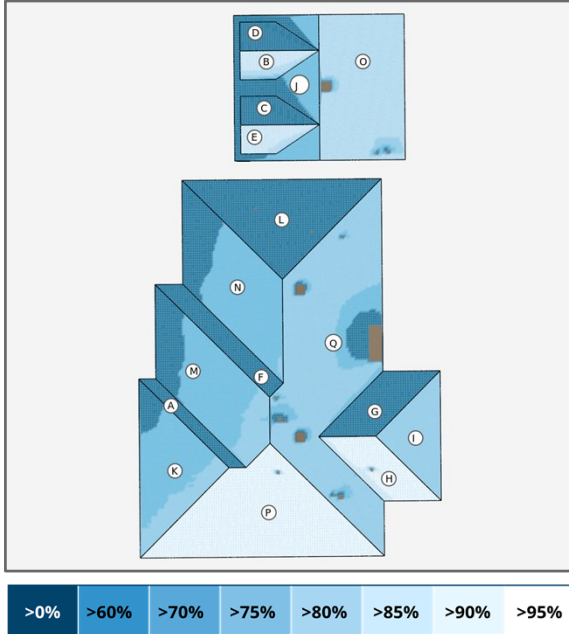
Area:	5,882 sq ft
Roof Facets:	17
Predominant Pitch:	27°
Number of Stories:	>1
Ridges/Hips:	353 ft
Valleys:	150 ft
Rakes:	114 ft
Eaves:	375 ft
Roof Obstructions:	17
Roof Obstructions Perimeter:	75 ft
Roof Obstructions Area:	40 sq ft

See an overview of all major measurements before you open the report

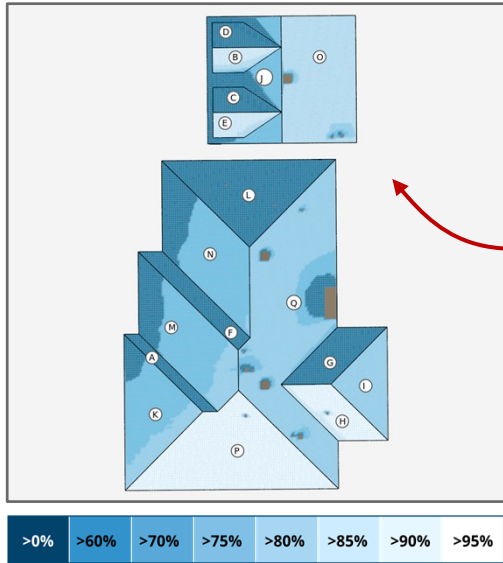
Annual Solar Values

3D model of the home with a TSRF heat map overlay. Each roof facet is identified with a letter for reference throughout the report

Reference the color key for the TSRF value range. Lighter portions of the roof have the best sun access values

Table gives annual average solar values for each facet. Values are calculated using a data point every 6" across the roof

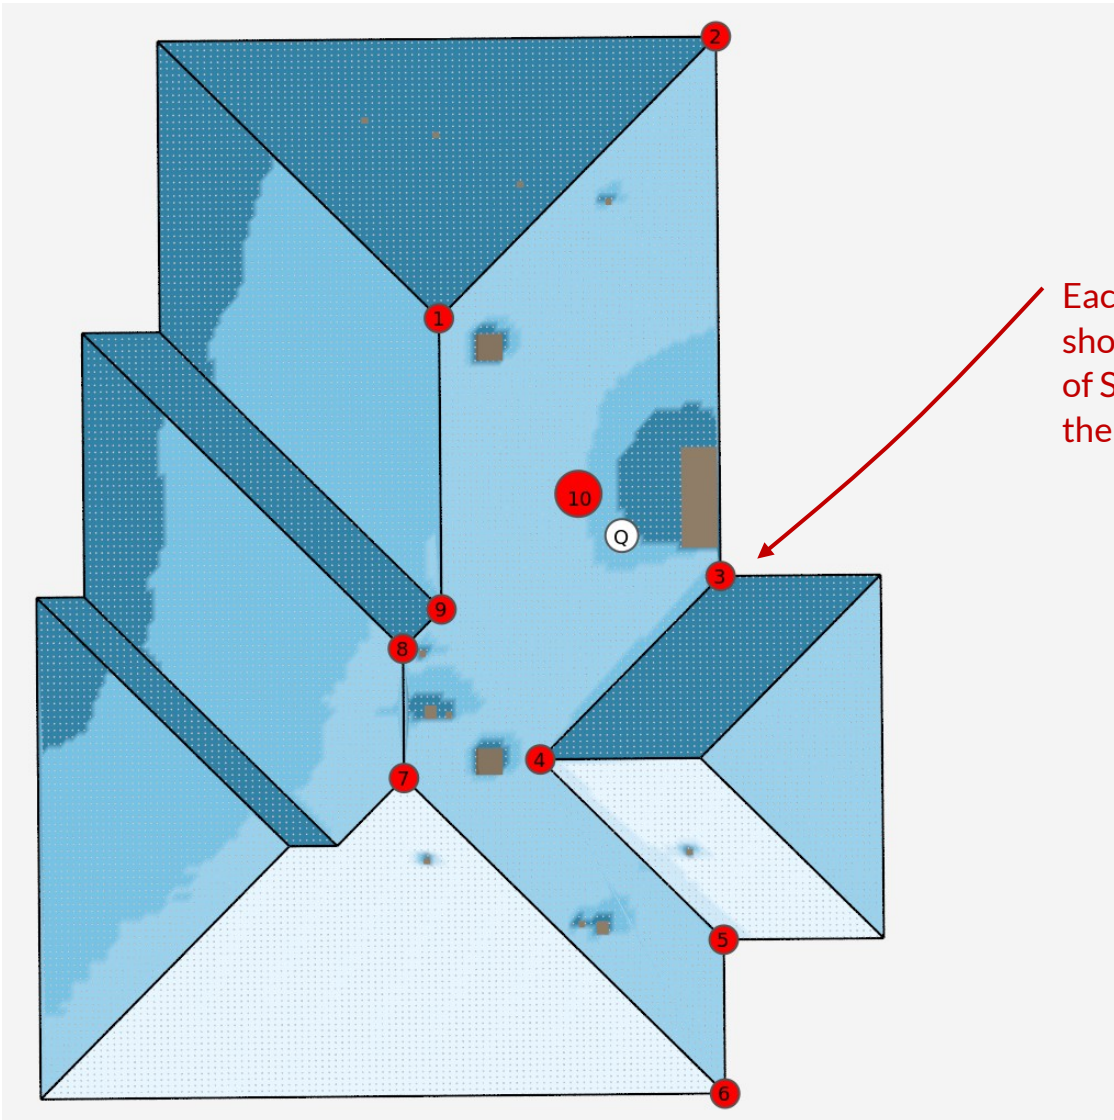
FACET Q DETAIL

Each red indicator shows the location of Skyline Views on the next page

TSRF. Red indicators refer to skyline views shown on the following page(s).

Monthly solar values for the facet

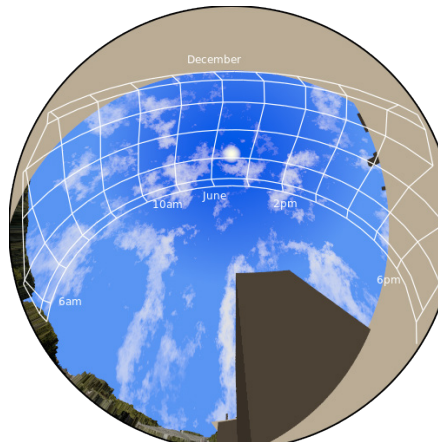
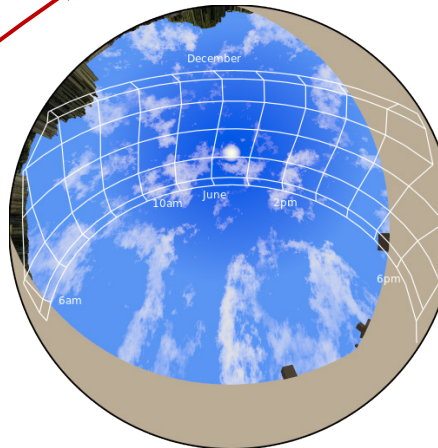
Facet Q - skyline views

The images here correspond to the previous facet detail page. They show a view looking out towards the sky to allow you to see any shade causing obstructions that would appear from the roof surface. The label on the images match the locations on the roof facet, allowing you to see obstruction views from the corners, and center point, of each facet.

Synthetic skylines show the 360 view from a specific spot on the roof to visualize shade causing obstructions

The roof is gray, roof obstructions on the roof itself are black, and the shapes along the border are trees and buildings surrounding the home

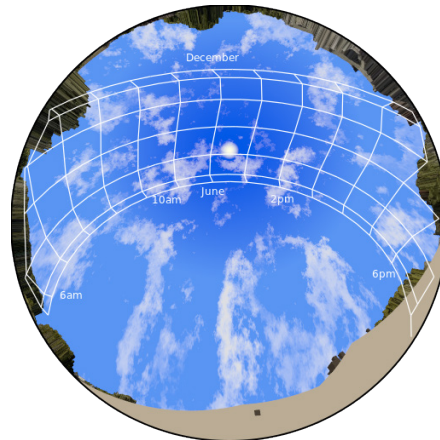
Facet Q - skyline views

The images here correspond to the previous facet detail page. They show a view looking out towards the sky to allow you to see any shade causing obstructions that would appear from the roof surface. The label on the images match the locations on the roof facet, allowing you to see obstruction views from the corners, and center point, of each facet.

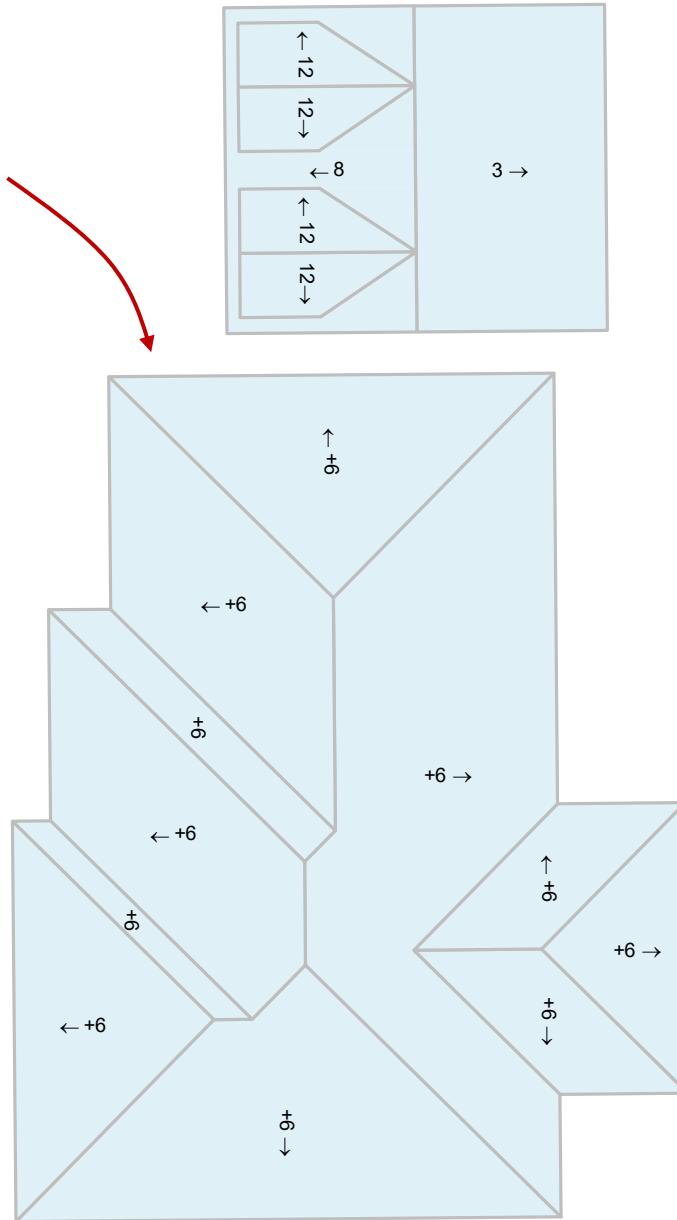
Pitch (on 12)

Pitches are labeled for facet areas larger than 20 square feet. In some cases, pitch labels have been removed for readability. Flat facets are labeled 'F'.

Accurate roof pitch per facet "on 12"

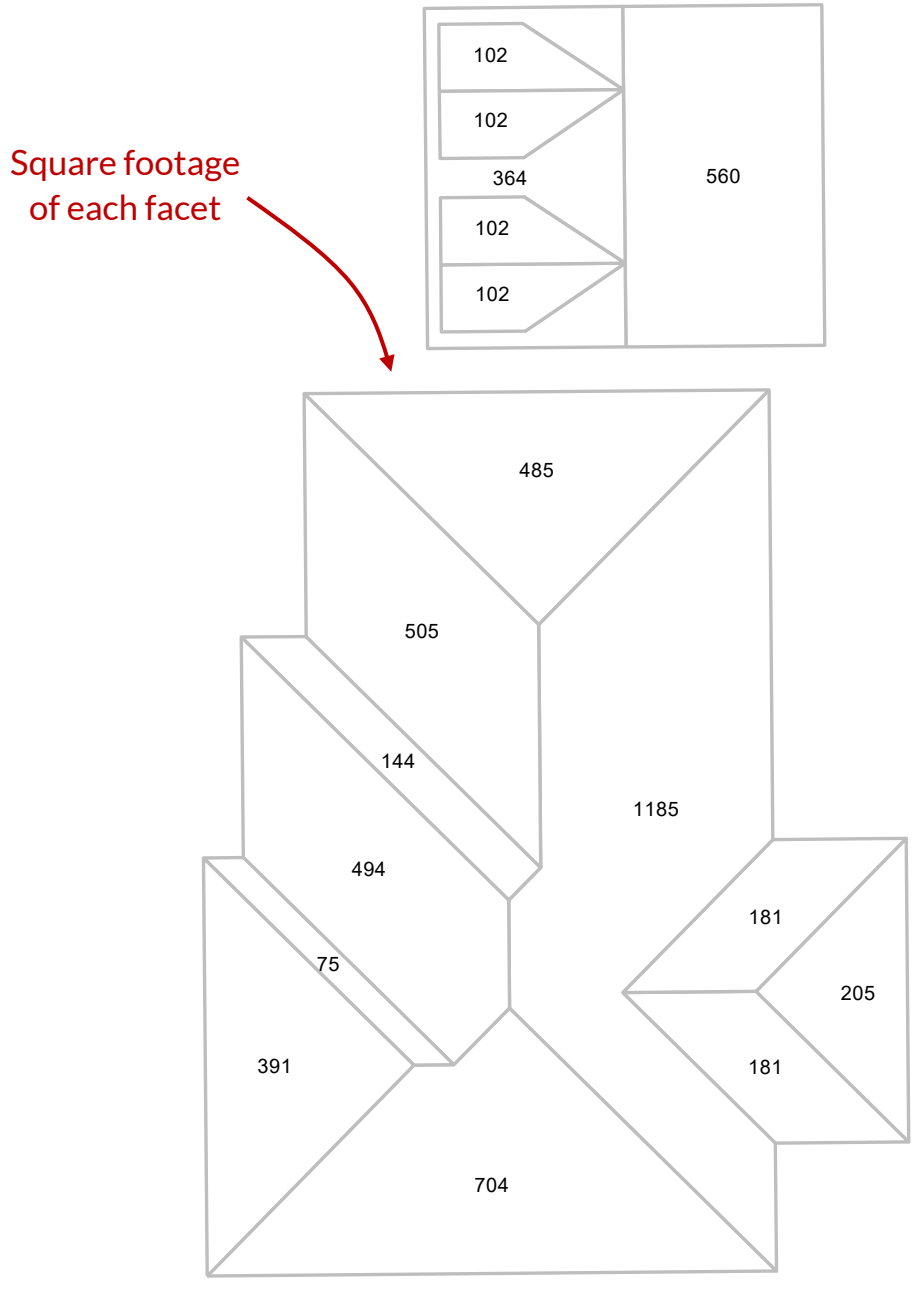
Area

The area is measured in square feet per roof facet. The values have been rounded to the nearest foot square.
