This report can be used for roofing and solar installations. Roof Report Summary page is at the end of the report

10497 S Royal Tee Cv South Jordan, UT 84095-3508

Report: 32437685

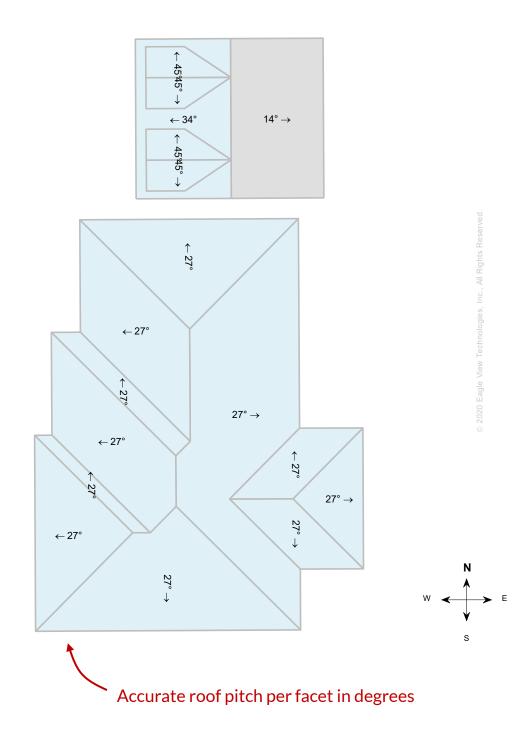
Pitch (Degrees)

Pitches are labeled for facet areas larger than 20 square feet. In some cases, pitch labels have been removed for readability. Flat facets are labeled 'F'.

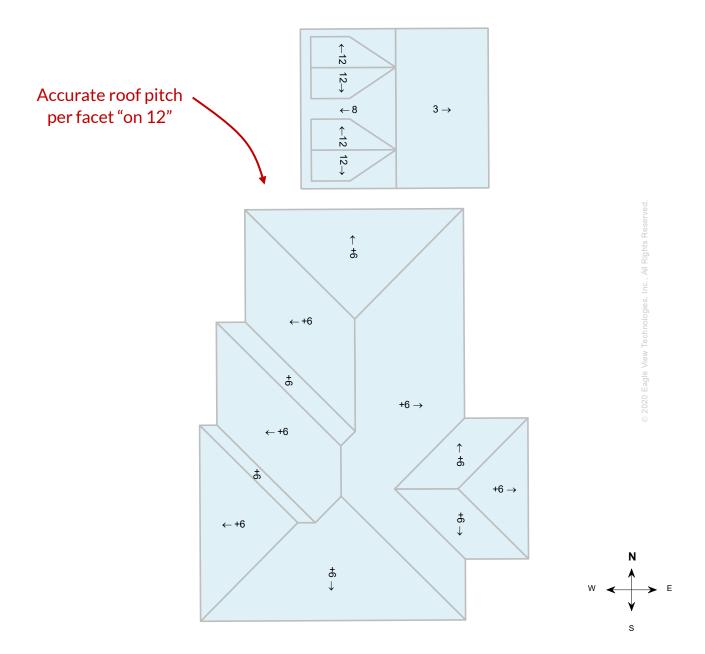
Pitch (on 12)

Pitches are labeled for facet areas larger than 20 square feet. In some cases, pitch labels have been removed for readability. Flat facets are labeled 'F'.

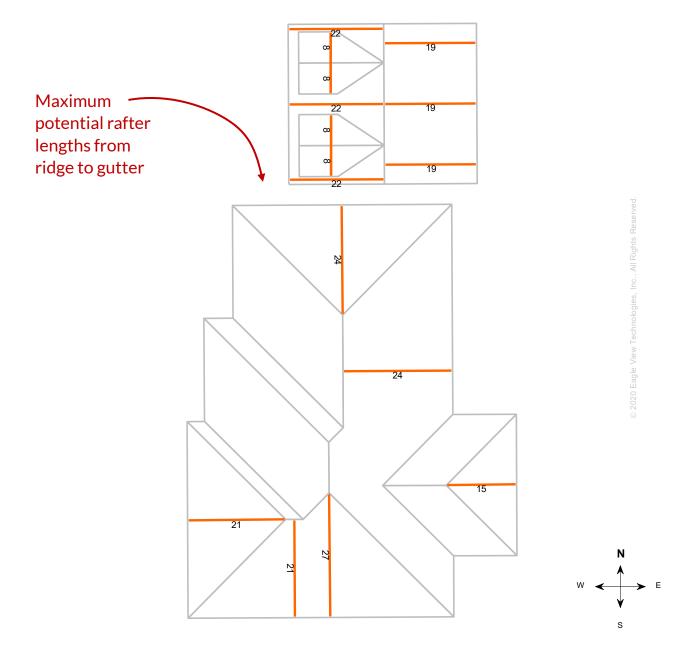
Rafters

Rafter lengths (rounded to the nearest whole number) over 5 feet. In some cases, segment labels have been removed for readability. Some numbers are prefaced by "+" signs to avoid confusion when rotated (e.g. +6 and +9).

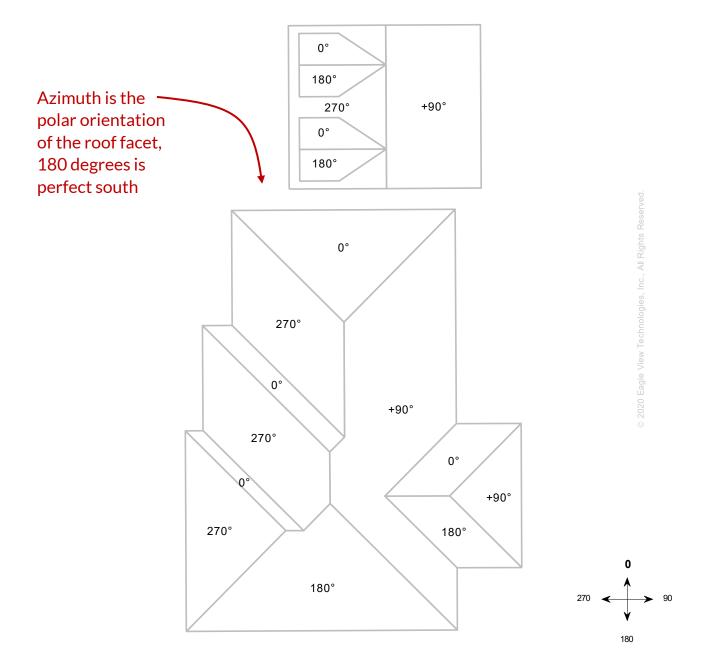
Azimuth

The azimuth is the orientation of the structure to true north. In this diagram roof facet directions are labeled in degrees, with 0° (360°) as true north. Flat facets are labeled as 'F'.

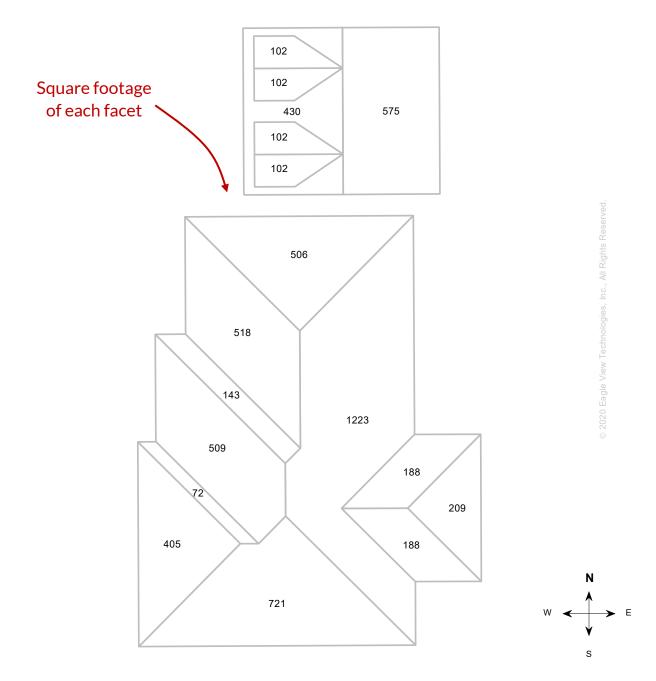
Area

The area is measured in square feet per roof facet. The values have been rounded to the nearest foot square.
