# Precise Aerial Roof Measurement Report

123 Main St. City, ST 12345

Report: 65659918

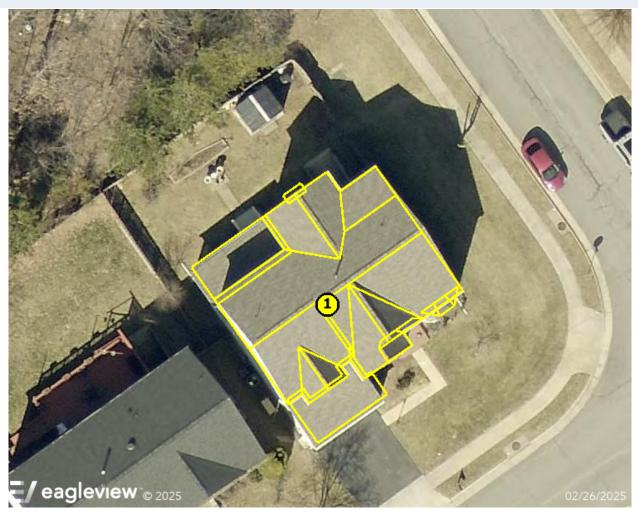
Roof	Total Area*	Pitch			# Facets	Suggested Waste Factor	
#1	31.7 squares	7/12	12/12	4/12	2/12	19	13%
#1		62%	16%	12%	8%	19

Roof	Total Area*	Pitch							
	31.7 squares	7/12	12/12	4/12	2/12	10/12	8/12	19	
#1		62%	16%	12%	8%	<1%	<1%		
		19.5 SQ	5.2 SQ	3.9 SQ	2.7 SQ	0.2 SQ	0.2 SQ

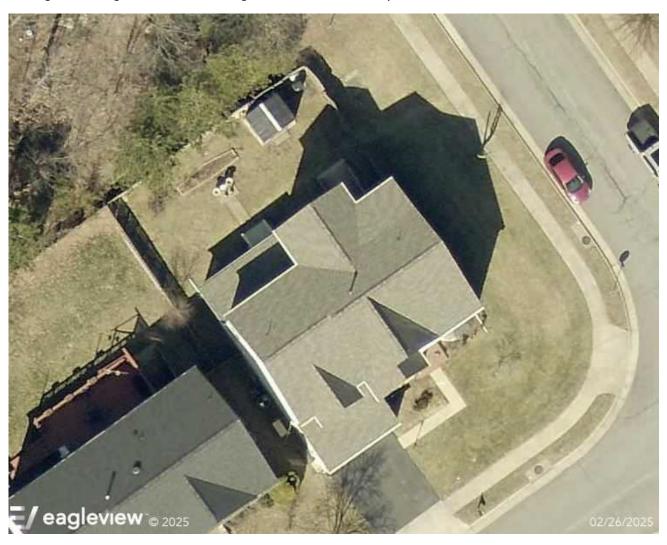
The following aerial images show different angles of this structure for your reference.
