# Precise Aerial Roof Measurement Report

123 Main St. City, ST 12345

Report: 62363078

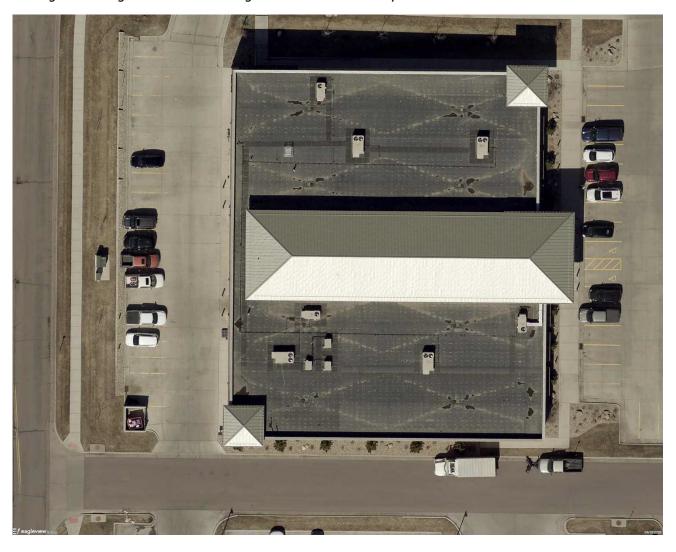
The following aerial images show different angles of this structure for your reference.
