1 Cardigan Ct, Newark, DE 19702-2043

Report: 46718049

# WALL AREA DIAGRAM

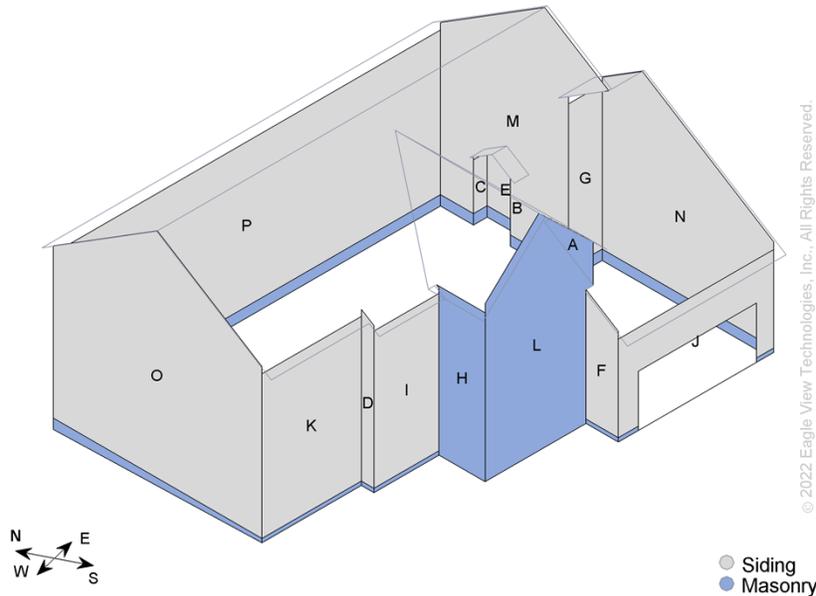
### North

Wall	Siding Wall Area (ft <sup>2</sup> )	Masonry Wall Area (ft <sup>2</sup> )
G	87.8	6.1
C	11.7	2.5
P	1012.2	70.0
<b>Total</b>	<b>1111.7</b>	<b>78.6</b>

### East

Wall	Siding Wall Area (ft <sup>2</sup> )	Masonry Wall Area (ft <sup>2</sup> )
N	439.2	30.6
E	37.0	6.7
A	0.0	13.6
M	418.9	16.5
<b>Total</b>	<b>895.1</b>	<b>67.4</b>

### South

Wall	Siding Wall Area (ft <sup>2</sup> )	Masonry Wall Area (ft <sup>2</sup> )
K	259.8	6.9
J	139.9	2.6
B	11.7	2.5
I	162.6	4.5
L	0.0	341.3
<b>Total</b>	<b>574.0</b>	<b>357.8</b>

### West

Wall	Siding Wall Area (ft <sup>2</sup> )	Masonry Wall Area (ft <sup>2</sup> )
D	33.4	0.9
F	60.4	2.2
O	694.5	26.1
H	0.0	123.6
<b>Total</b>	<b>788.3</b>	<b>152.8</b>

Wall Area including Windows & Doors	=	4025.7 ft <sup>2</sup>
Total Siding Area	=	3369.1 ft <sup>2</sup>
Total Masonry Area	=	656.6 ft <sup>2</sup>

**\*Calculation Note: Garage door surface areas are subtracted from the total; window and door surface areas are not.**

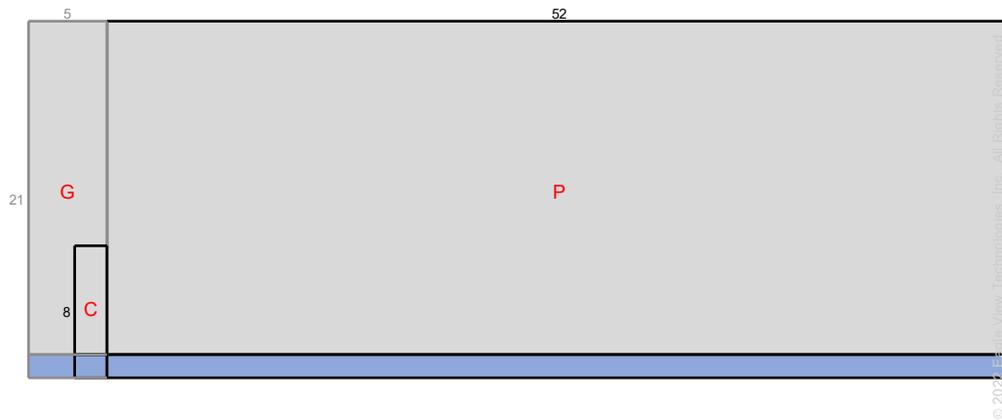
# NORTH ELEVATION DIAGRAM

- Siding
- Masonry

Wall	Siding Wall Area (ft <sup>2</sup> )	Masonry Wall Area (ft <sup>2</sup> )
G	87.8	6.1
C	11.7	2.5
P	1012.2	70.0
<b>Total</b>	<b>1111.7</b>	<b>78.6</b>

**Note: On-site verification of yellow shaded areas is needed.** This diagram shows segment lengths rounded to the nearest whole number. The wall area in square feet (rounded to the nearest tenth) is based on the actual (non-rounded) value of each segment length. Windows and doors have not been subtracted from these measurements.

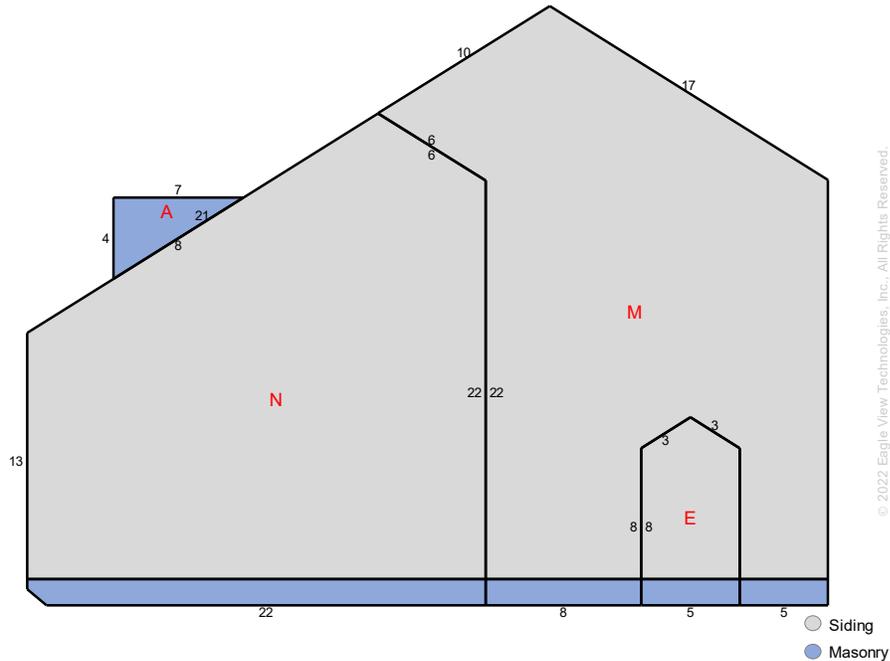
# EAST ELEVATION DIAGRAM

Wall	Siding Wall Area (ft <sup>2</sup> )	Masonry Wall Area (ft <sup>2</sup> )
N	439.2	30.6
E	37.0	6.7
A	0.0	13.6
M	418.9	16.5
<b>Total</b>	<b>895.1</b>	<b>67.4</b>

**Note: On-site verification of yellow shaded areas is needed.** This diagram shows segment lengths rounded to the nearest whole number. The wall area in square feet (rounded to the nearest tenth) is based on the actual (non-rounded) value of each segment length. Windows and doors have not been subtracted from these measurements.

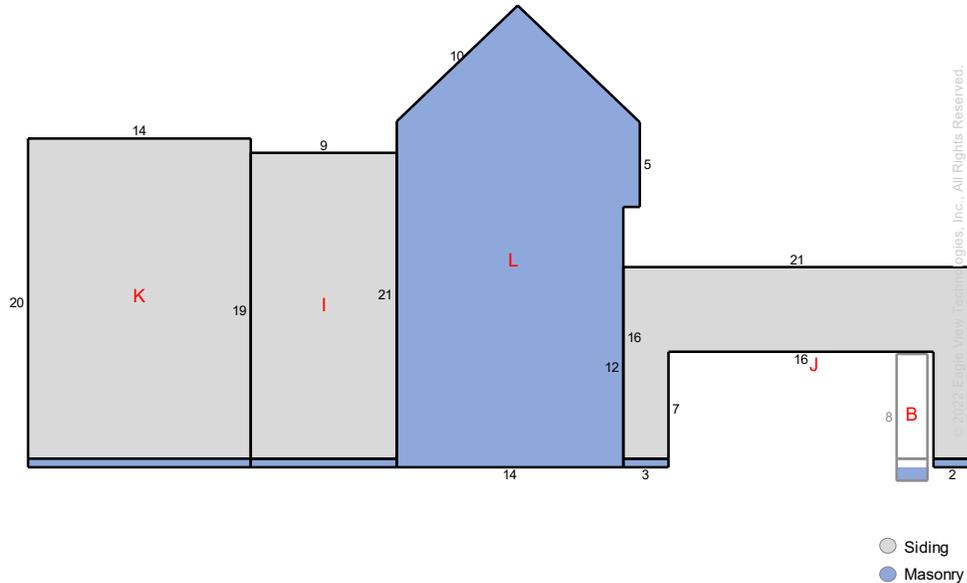
# SOUTH ELEVATION DIAGRAM

Wall	Siding Wall Area (ft <sup>2</sup> )	Masonry Wall Area (ft <sup>2</sup> )
K	259.8	6.9
J	139.9	2.6
B	11.7	2.5
I	162.6	4.5
L	0.0	341.3
<b>Total</b>	<b>574.0</b>	<b>357.8</b>

**Note: On-site verification of yellow shaded areas is needed.** This diagram shows segment lengths rounded to the nearest whole number. The wall area in square feet (rounded to the nearest tenth) is based on the actual (non-rounded) value of each segment length. Windows and doors have not been subtracted from these measurements.

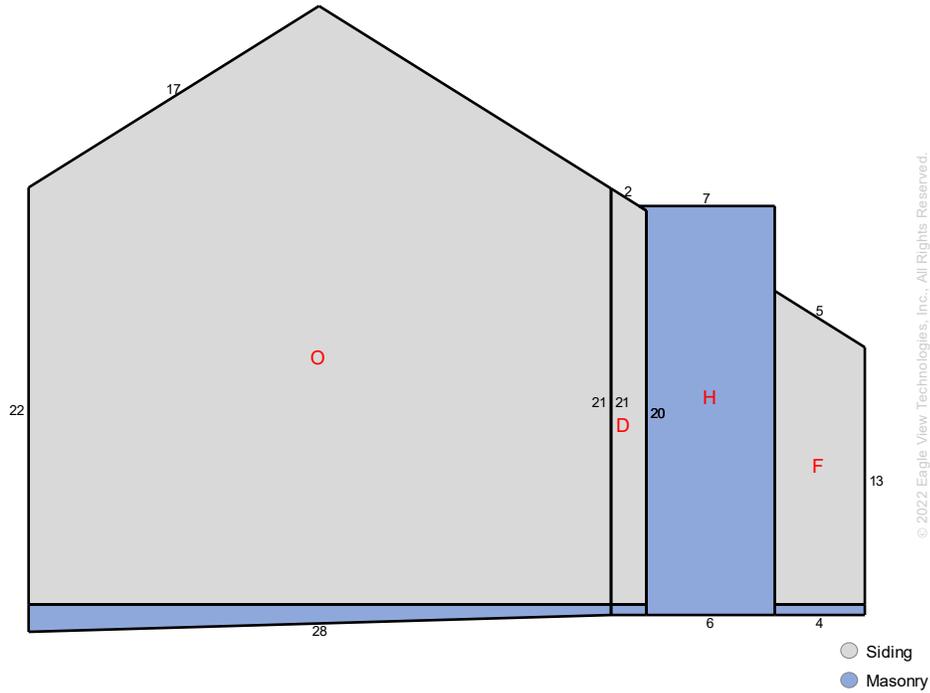
**WEST ELEVATION DIAGRAM**

Wall	Siding Wall Area (ft <sup>2</sup> )	Masonry Wall Area (ft <sup>2</sup> )
D	33.4	0.9
F	60.4	2.2
O	694.5	26.1
H	0.0	123.6
<b>Total</b>	<b>788.3</b>	<b>152.8</b>

**Note: On-site verification of yellow shaded areas is needed.** This diagram shows segment lengths rounded to the nearest whole number. The wall area in square feet (rounded to the nearest tenth) is based on the actual (non-rounded) value of each segment length. Windows and doors have not been subtracted from these measurements.
