123 Main St., City, ST 00000

Report: SAMPLE

Roof Details

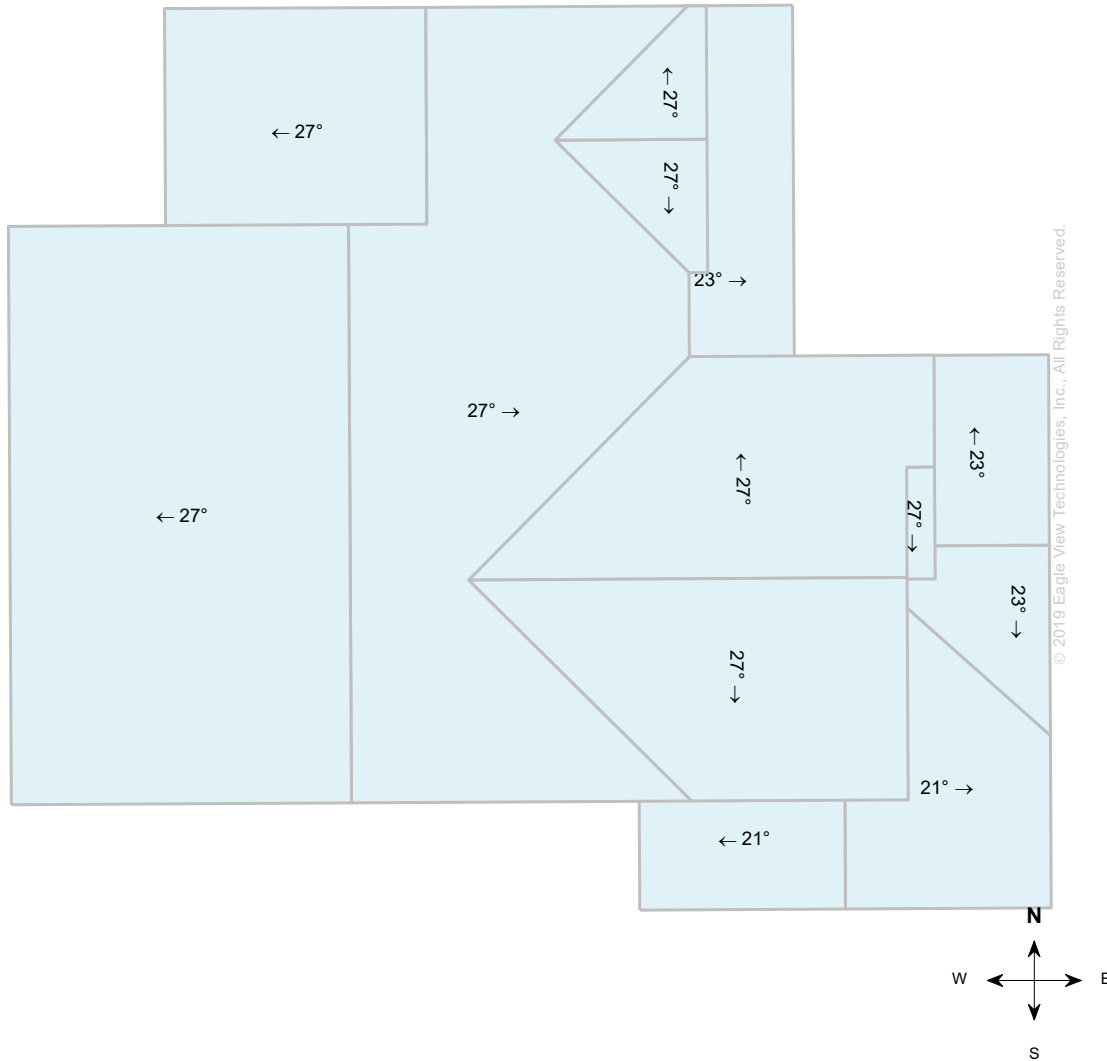
Pitch Diagram (Degrees)

In this diagram pitch values are shown in degrees, and arrows indicate slope direction. The predominant pitch is 27 degrees.

Note: This diagram contains labeled pitches for facet areas larger than 20 square feet. In some cases, pitch labels have been removed for readability.

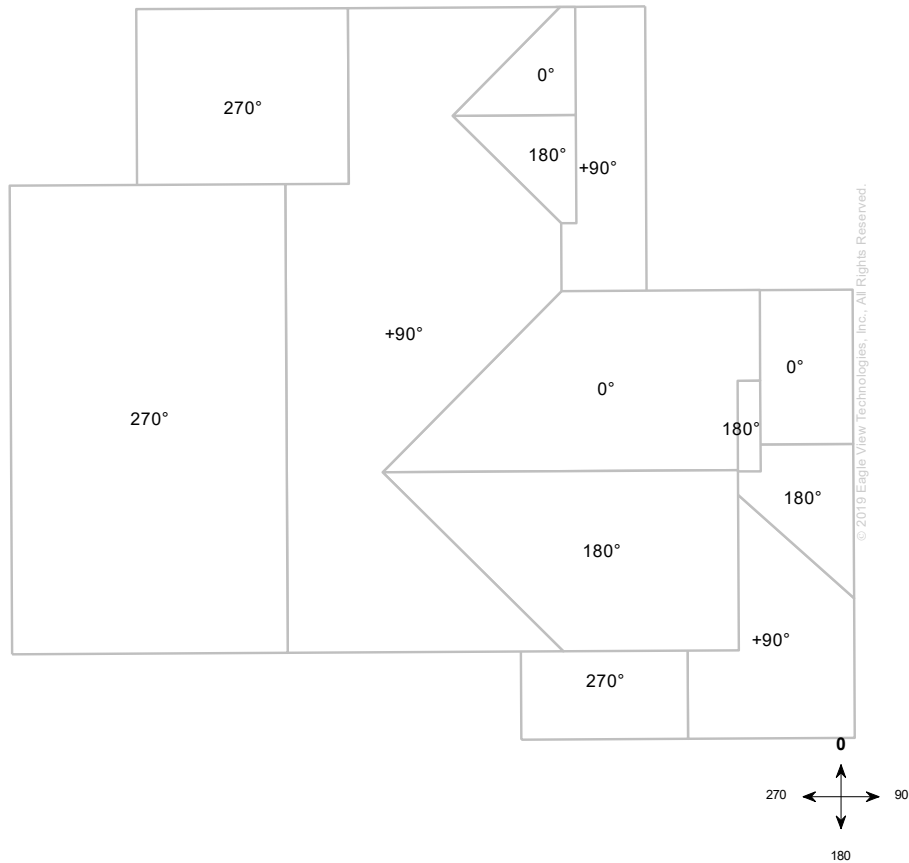
Azimuth Diagram

In this diagram roof facet directions are labeled in degrees. The southern-facing facets make up 385 sq ft, and 14% of this roof.

Note: Total areas and percents are based upon direction and assume 360° (0°) as true north. Facet letters match the Notes Diagram.

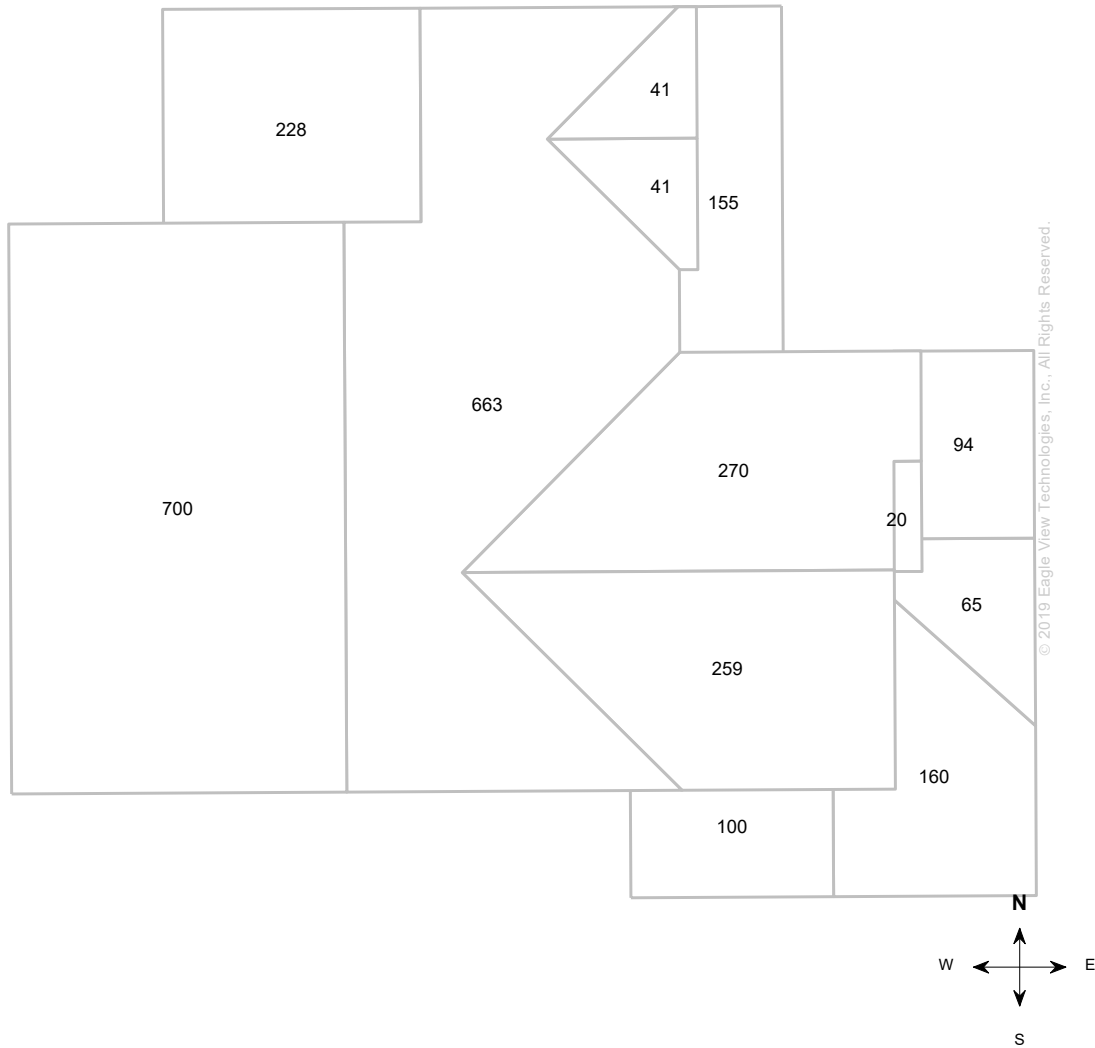
Area Diagram

Total Area = 2,794 sq ft, with 13 facets.

Note: This diagram shows the square feet of each roof facet (rounded to the nearest foot). The total area in square feet, at the top of this page, is based on the non-rounded values of each roof facet (rounded to the nearest square foot after being totaled).

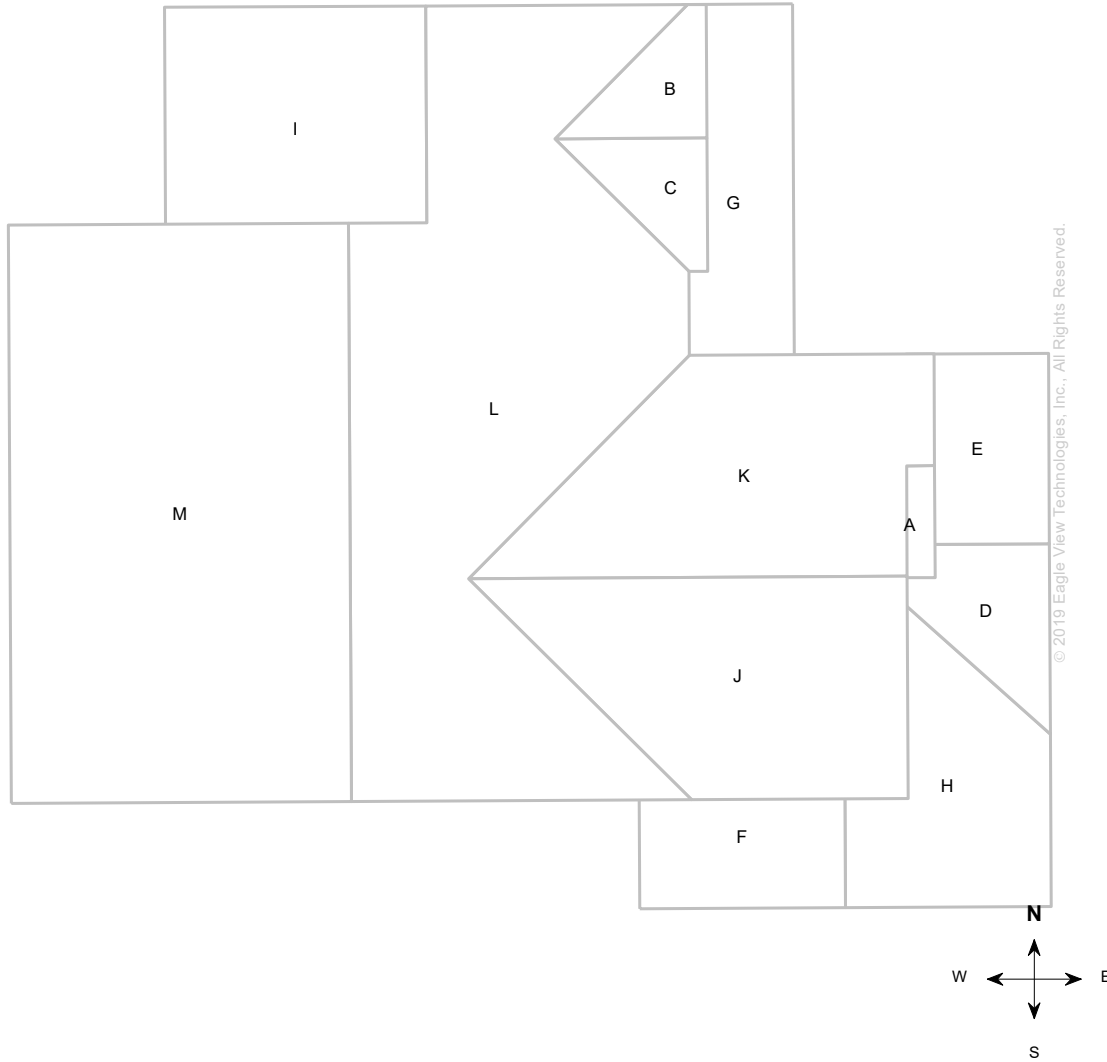
Notes Diagram

Roof facets are labeled from smallest to largest (A to Z) for easy reference.
