123 Main St, City, ST 12345-4321

WALL AREA DIAGRAM

WALL MEASUREMENT SUMMARY

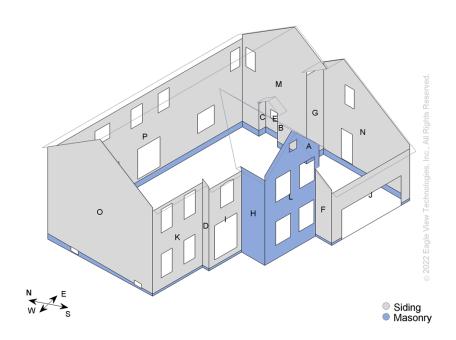
Wall	Siding Wall Area (ft²)	Masonry Wall Area (ft²)
G	87.8	6.1
С	11.7	2.5
Р	867.9	70.0
Total	967.4	78.6

Wall	Siding Wall Area (ft²)	Masonry Wall Area (ft²)
N	407.0	30.6
Е	33.0	6.7
Α	0.0	13.6
M	407.7	16.5
Total	847.7	67.4

Wall	Siding Wall Area (ft²)	Masonry Wall Area (ft²)
K	193.8	6.9
J	139.9	2.6
В	11.7	2.5
I	96.5	4.5
L	0.0	249.3
Total	441.9	265.8

Wall	Siding Wall Area (ft²)	Masonry Wall Area (ft²)
D	33.4	0.9
F	60.4	2.2
0	692.8	23.8
Н	0.0	123.6
Total	786.6	150.5

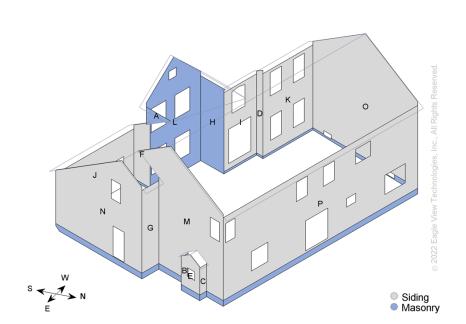
ALTERNATE WALL VIEW

Wall	Siding Wall Area (ft²)	Masonry Wall Area (ft²)
G	87.8	6.1
С	11.7	2.5
Р	867.9	70.0
Total	967.4	78.6

Wall	Siding Wall Area (ft²)	Masonry Wall Area (ft²)
N	407.0	30.6
Е	33.0	6.7
Α	0.0	13.6
Μ	407.7	16.5
Total	847.7	67.4

Wall	Siding Wall Area (ft²)	Masonry Wall Area (ft²)
K	193.8	6.9
J	139.9	2.6
В	11.7	2.5
I	96.5	4.5
L	0.0	249.3
Total	441.9	265.8

Wall	Siding Wall Area (ft²)	Masonry Wall Area (ft²)
D	33.4	0.9
F	60.4	2.2
0	692.8	23.8
Н	0.0	123.6
Total	786.6	150.5

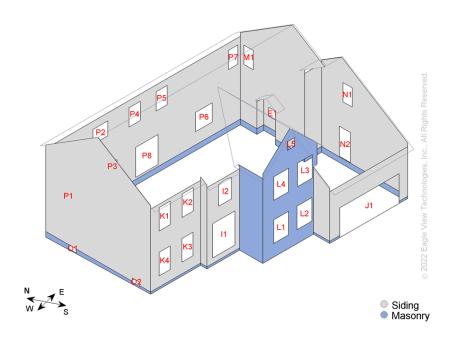
WINDOW & DOOR DIAGRAM

Note: Window & door measurements include trim.

Window/Door	Area (ft²)	Perimeter (ft)	Dimensions W x H (ft)
P1	24.8	20.0	5.5 x 4.5
P2	14.0	15.0	4.0 x 3.5
P3	5.0	9.0	2.5 x 2.0
P4	13.5	15.0	3.0 x 4.5
P5	13.5	15.0	3.0 x 4.5
P6	20.2	18.0	4.5 x 4.5
P7	11.2	14.0	2.5 x 4.5
P8	42.0	26.0	6.0 x 7.0
Total	144.2	132.0	n/a

Window/Door	Area (ft²)	Perimeter (ft)	Dimensions W x H (ft)
E1	4.0	8.0	2.0 x 2.0
M1	11.2	14.0	2.5 x 4.5
N1	11.2	14.0	2.5 x 4.5
N2	21.0	20.0	3.0 x 7.0
Total	47.4	56.0	n/a

Window/Door	Area (ft²)	Perimeter (ft)	Dimensions W x H (ft)
I1	48.0	28.0	6.0 x 8.0
I2	18.1	17.0	3.5 x 5.3
J1	111.3	46.0	16.0 x 7.0
K1	16.5	17.0	3.0 x 5.5
K2	16.5	17.0	3.0 x 5.5

Window/Door	Area (ft²)	Perimeter (ft)	Dimensions W x H (ft)
01	2.0	6.0	2.0 x 1.0
O2	2.0	6.0	2.0 x 1.0
Total	4.0	12.0	n/a

K3	16.5	17.0	3.0 x 5.5
K4	16.5	17.0	3.0 x 5.5
L1	22.0	19.0	4.0 x 5.5
L2	22.0	19.0	4.0 x 5.5
L3	22.0	19.0	4.0 x 5.5
L4	22.0	19.0	4.0 x 5.5
L5	4.0	8.0	2.0 x 2.0
Total	335.4	243.0	n/a

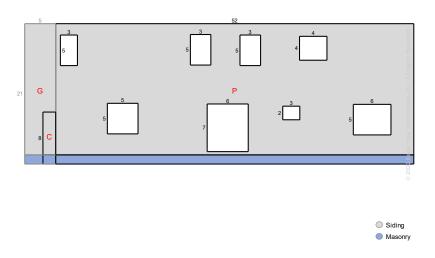
NORTH ELEVATION DIAGRAM

Top of Siding Walls = 58.8 ft Bottom of Siding Walls = 58.8 ft

Wall	Siding Wall Area (ft²)	Masonry Wall Area (ft²)	Window & Door Area (ft²)	Window & Door Perimeter (ft)	Window & Door Count
G	87.8	6.1	0	0	0
С	11.7	2.5	0	0	0
Р	867.9	70.0	144.2	132.0	8
Total	967.4	78.6	144.2	132.0	8

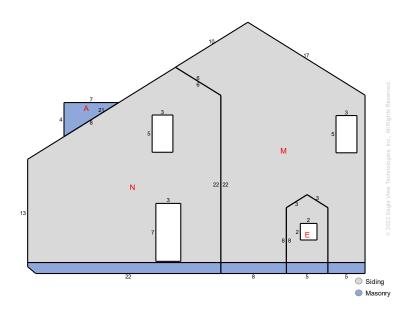
EAST ELEVATION DIAGRAM

Top of Siding Walls = 60.1 ftBottom of Siding Walls = 52.8 ft

Wall	Siding Wall Area (ft²)	Masonry Wall Area (ft²)	Window & Door Area (ft²)	Window & Door Perimeter (ft)	Window & Door Count
N	407.0	30.6	32.2	34.0	2
Е	33.0	6.7	4.0	8.0	1
Α	0.0	13.6	0	0	0
M	407.7	16.5	11.2	14.0	1
Total	847.7	67.4	47.4	56.0	4

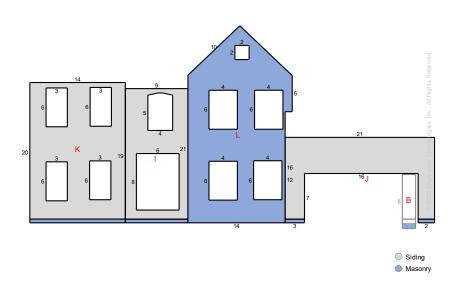
SOUTH ELEVATION DIAGRAM

Top of Siding Walls = 45.2 ft Bottom of Siding Walls = 45.2 ft

Wall	Siding Wall Area (ft²)	Masonry Wall Area (ft²)	Window & Door Area (ft²)	Window & Door Perimeter (ft)	Window & Door Count
K	193.8	6.9	66.0	68.0	4
J	139.9	2.6	111.3	46.0	1
В	11.7	2.5	0	0	0
I	96.5	4.5	66.1	45.0	2
L	0.0	249.3	92.0	84.0	5
Total	441.9	265.8	335.4	243.0	12

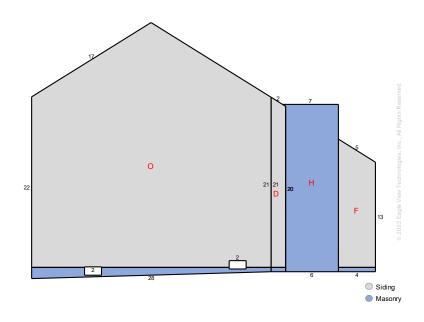
WEST ELEVATION DIAGRAM

Top of Siding Walls = 40.4 ft Bottom of Siding Walls = 34.3 ft

Wall	Siding Wall Area (ft²)	Masonry Wall Area (ft²)	Window & Door Area (ft²)	Window & Door Perimeter (ft)	Window & Door Count
D	33.4	0.9	0	0	0
F	60.4	2.2	0	0	0
0	692.8	23.8	4.0	12.0	2
Н	0.0	123.6	0	0	0
Total	786.6	150.5	4.0	12.0	2
